31 August 2018

Our Ref: 419748

**Geotechnical and Foundation Report: Lot 21, Manakura Neighbourhood, Karamū Subdivision, Riccarton, Christchurch**

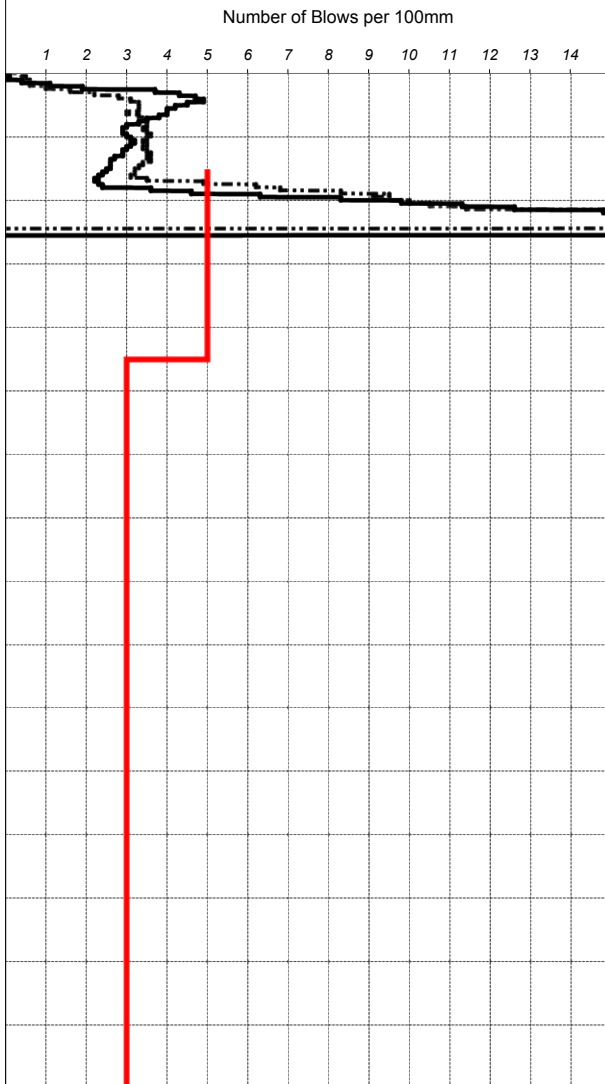
Lot **21**  
 D.P. **518068**

Depth (m)	Test Location - Lot 21, B	Water
0.0 - 0.2	FILL: silty TOPSOIL, with trace gravel; dark brown. Damp; trace rootlets.	Groundwater Not Encountered
0.2 - 0.4	FILL: sandy fine to medium GRAVEL; light brown.	
0.4 - 3.0	EOH: 0.5m - Target depth. 0.60m: Indicative depth of controlled fill at P03 and B. 0.65m: Indicative depth of controlled fill at P02.

Minimum penetration resistance (based on 300mm wide footing founded at 300mm depth) required for "Good Ground" as defined in the Acceptable Solutions and Verification Methods for NZBC Clause B1 Structure.

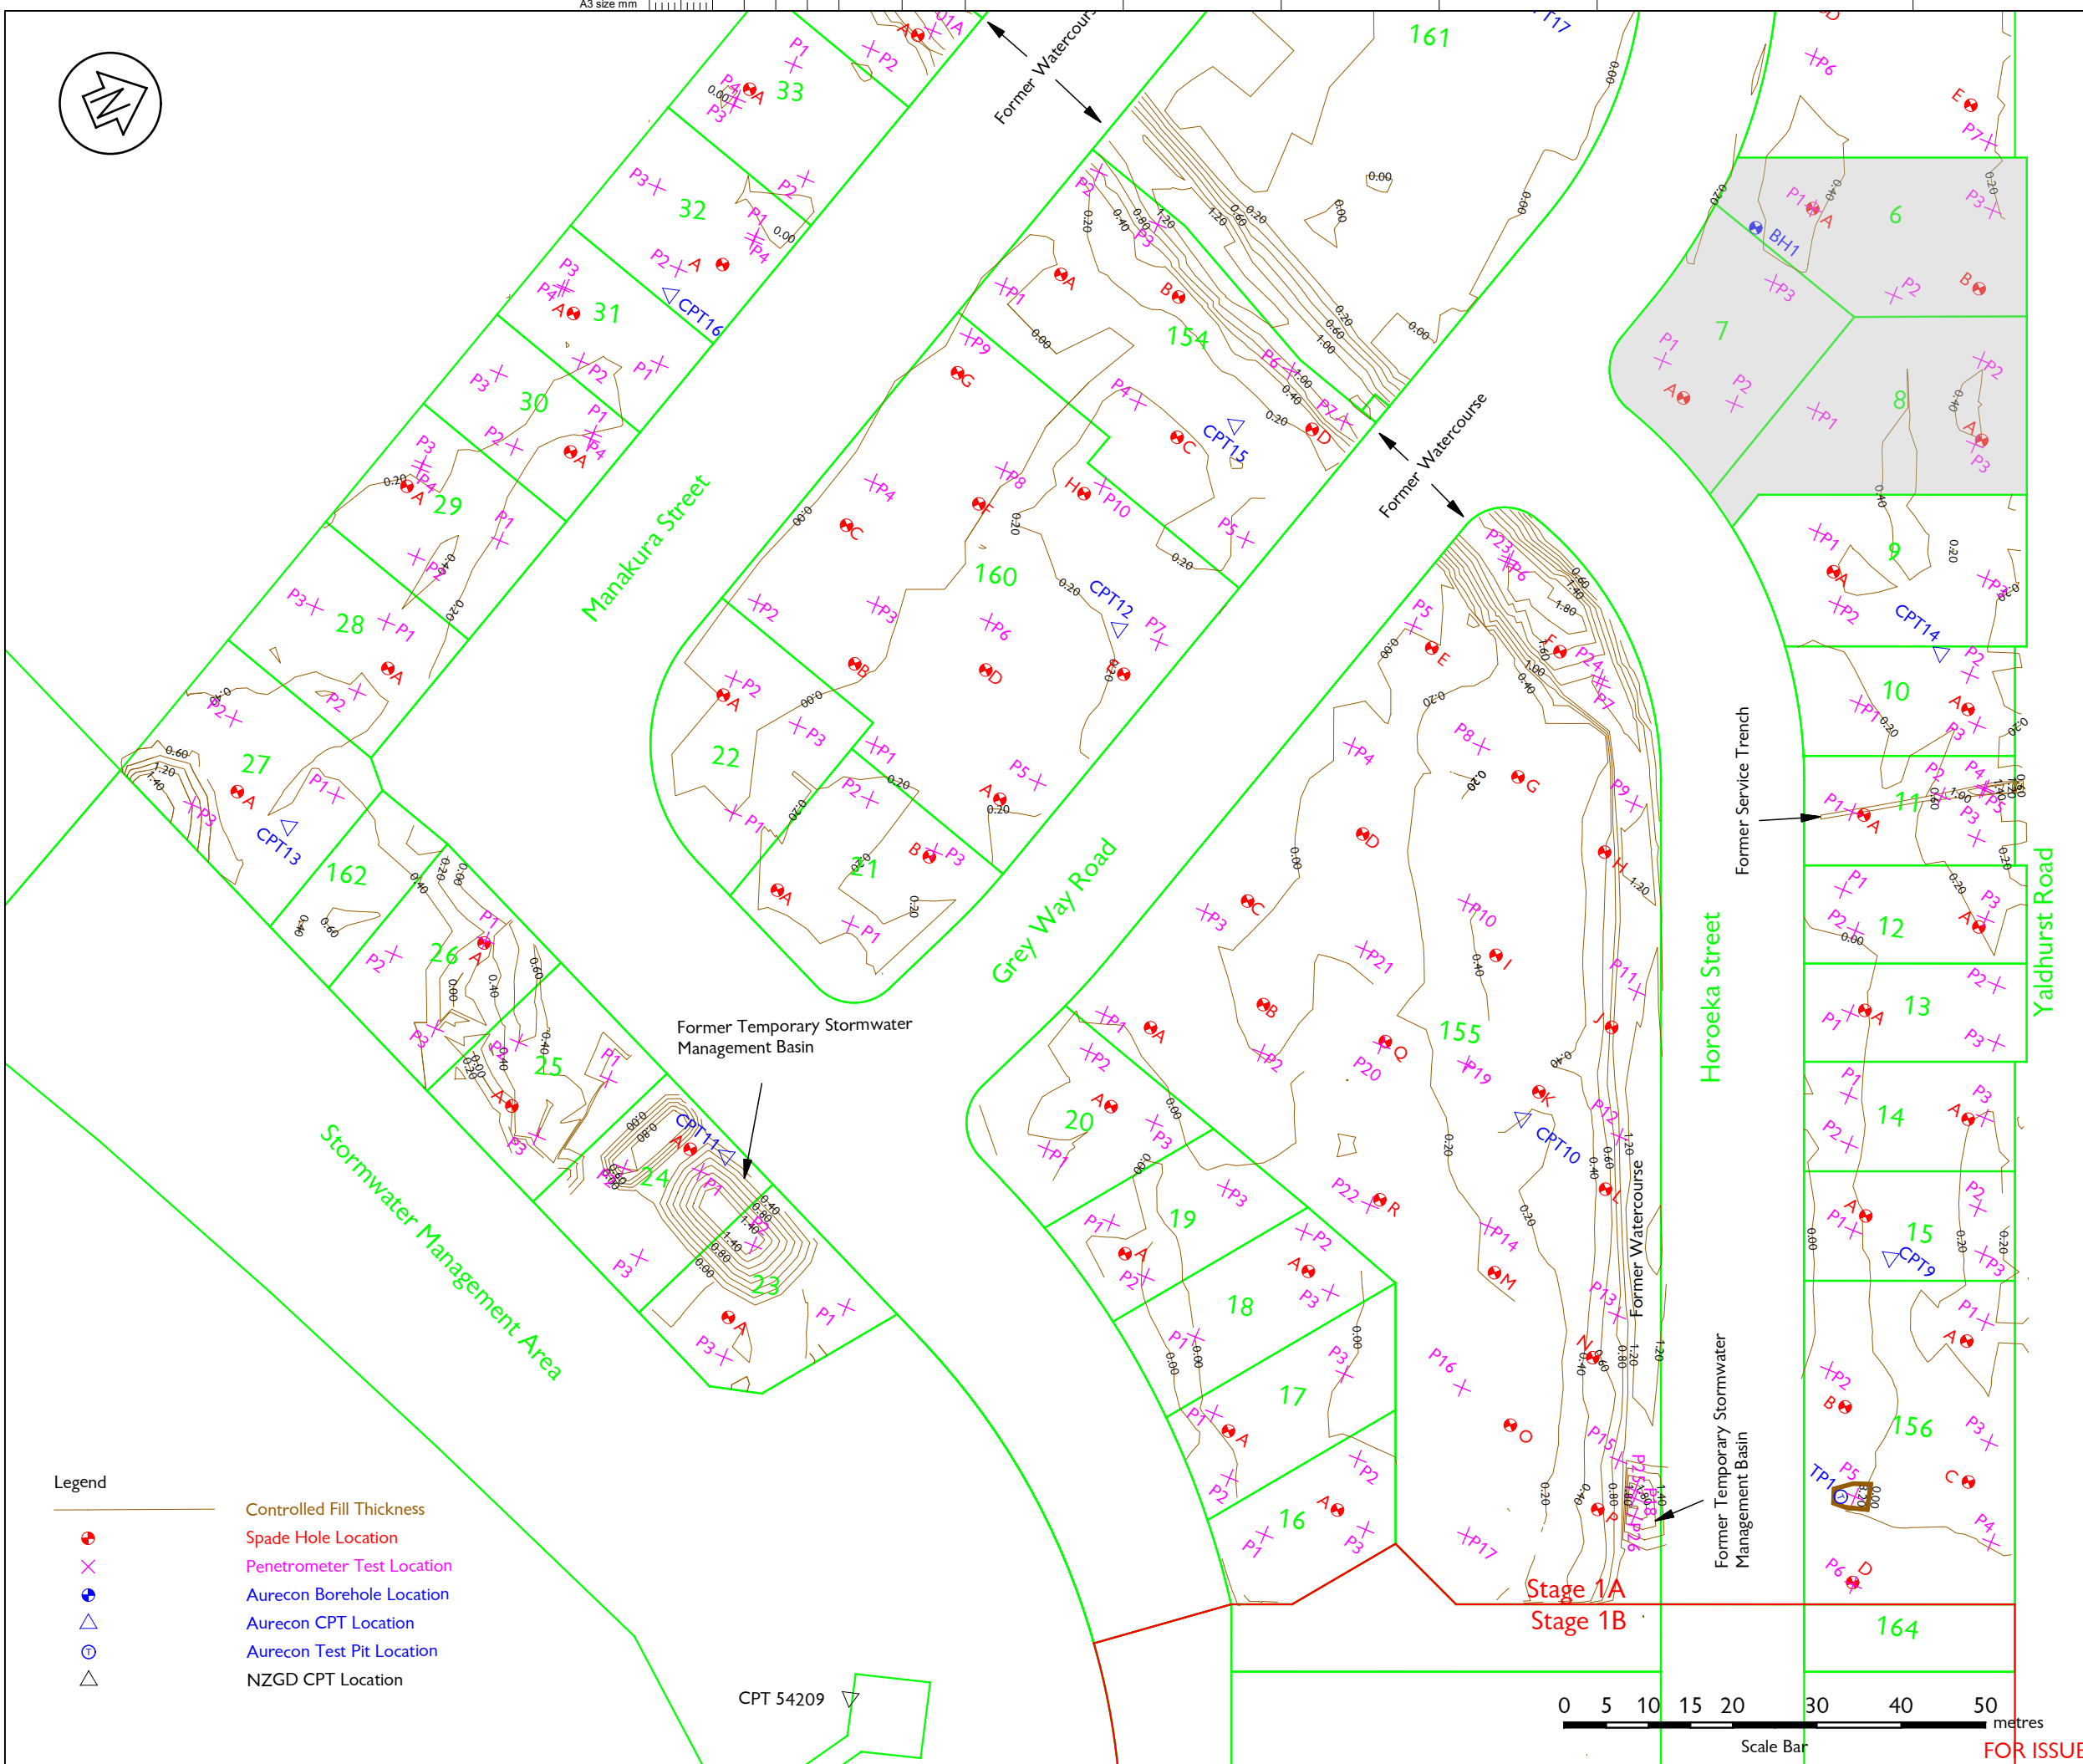
Drawing Title  
**Geotechnical Test Locations and Controlled/ Engineered Fill Thickness Contour Plan**

**Notes:**  
 1) The Aurecon test locations shown have been sourced from Aurecon New Zealand Limited - Champions Mile Geotechnical Investigation Report, Dated 23 September 2016. The coordinates of test locations have not been confirmed or verified by Eliot Sinclair.  
 2) Lots 6, and 8 have been amalgamated into one lot - Lot 6 under consent variation RMA/2017/2099/A.
