29 August 2018

Our Ref: 419748

Geotechnical and Foundation Report: Lot 23, Manakura Neighbourhood, Karamū Subdivision, Riccarton, Christchurch

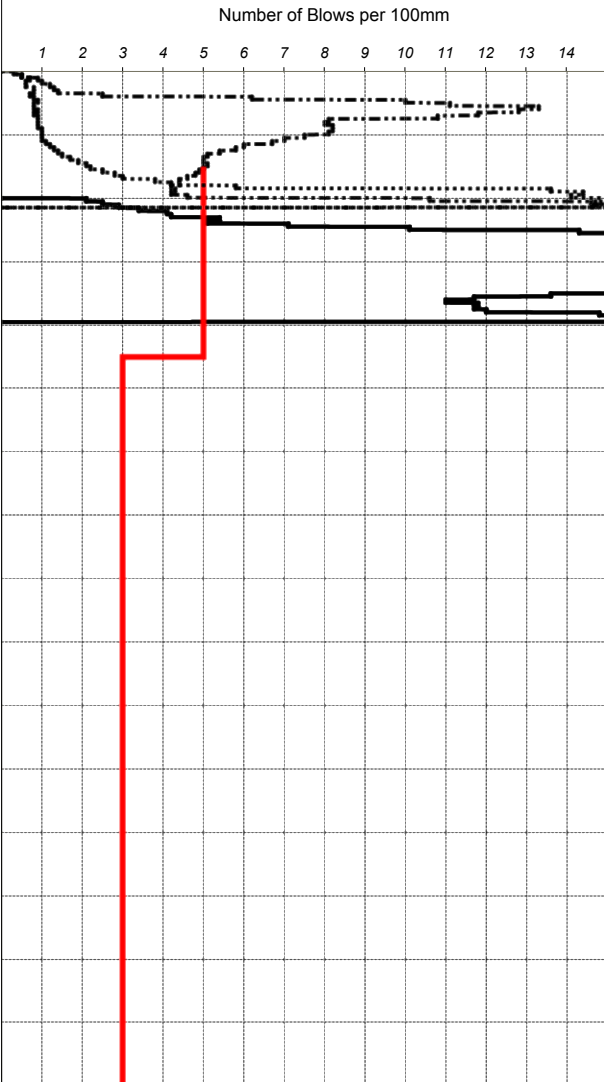
SCALA PENETROMETER TEST RESULTS

Typically, below the topsoil layer the penetrometer test results generally indicate a geotechnical ultimate bearing capacity >300 kPa. Standard foundations for dwellings within the scope of NZS 3604:2011 are suitable. Refer to MBIE Section 5.2 *Overview of new foundations options*.

Scala penetrometers undertaken by Canterbury Geotest Ltd using a Hydraulic penetrometer rig. At P 01, testing started 0.4m below ground level as topsoil had not been placed in this area at the time of testing.

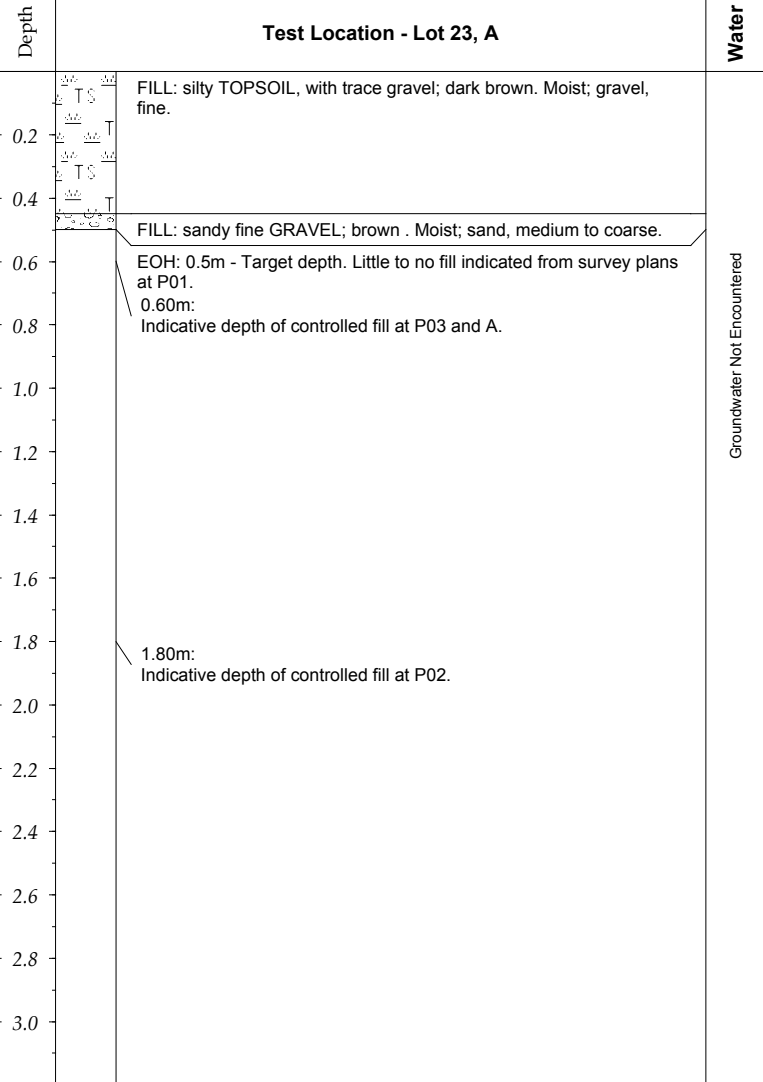
SOIL PROFILE

Depth (Below Ground Level)	Soil Description	Information Source
0m to 0.4-0.45m	Silty TOPSOIL FILL.	Spade hole following the earthworks.
0.4-0.45m to 0.5-1.8m	Controlled Fill: Sandy GRAVEL.	Observations made during the earthworks.
0.4-0.45 to 0.8-1.8m	Insitu silts and sands.	Refusal depths from penetrometers and nearby CPTs.
0.6-1.8m to >10m	Insitu sandy gravels.	Site wide subdivision testing.
