Geotechnical and Foundation Report: Lot 27, Manakura Neighbourhood, Karamū Subdivision, Riccarton, Christchurch

This report provides the geotechnical appraisal and foundation recommendations for Lot 27 (DP 518068), Manakura Neighbourhood, Karamū Subdivision, Riccarton, Christchurch.

SITE INVESTIGATION RECORD

Drawing Title
Geotechnical Test Locations and Controlled/ Engineered Fill Thickness Contour Plan

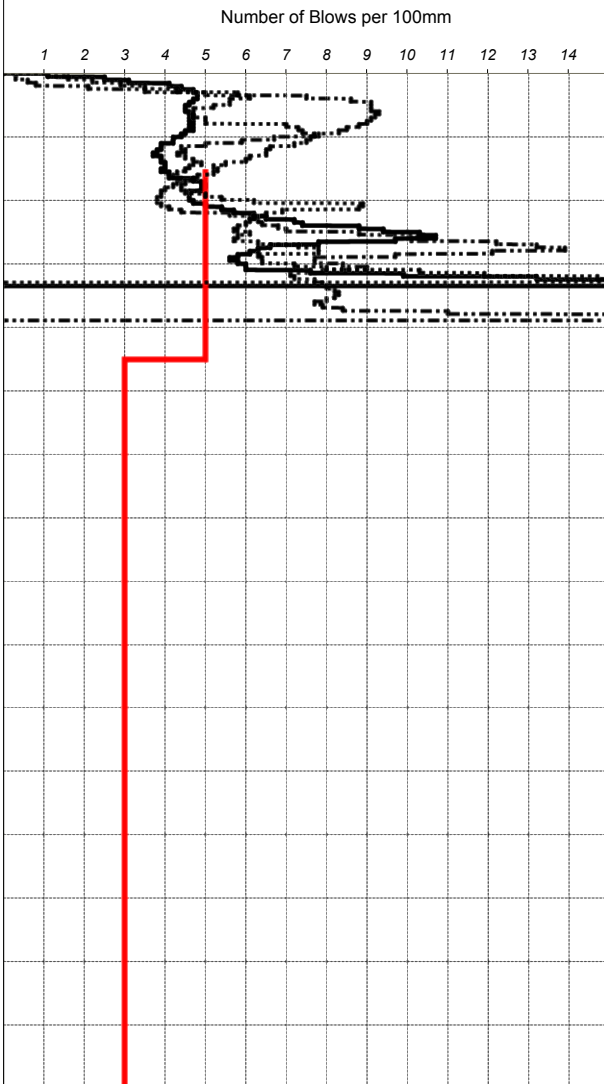
SCALA PENETROMETER TEST RESULTS

Typically, below the topsoil layer the penetrometer test results generally indicate a geotechnical ultimate bearing capacity >300 kPa. Standard foundations for dwellings within the scope of NZS 3604:2011 are suitable. Refer to MBIE Section 5.2 *Overview of new foundations options*.

Scala penetrometers undertaken by Canterbury Geotest Ltd using a Hydraulic penetrometer rig.

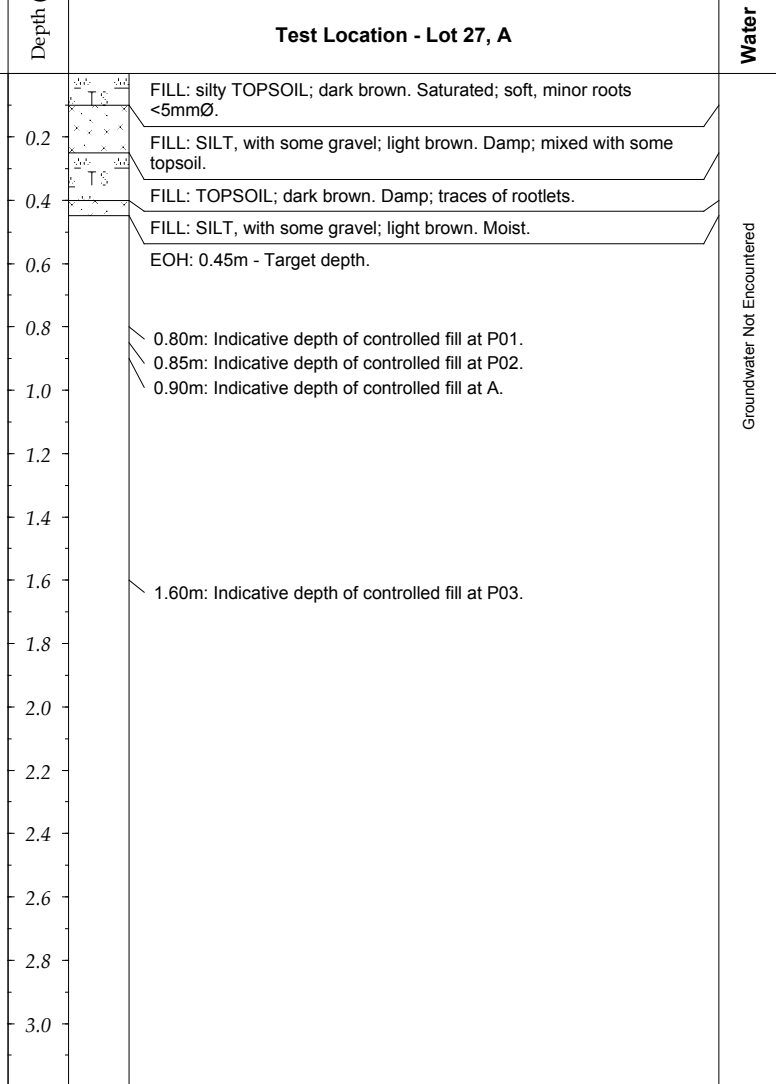
SOIL PROFILE

Depth (Below Ground Level)	Soil Description	Information Source
0m to 0.4m	Silty TOPSOIL FILL.	Spade hole and survey data following the earthworks.
0.4m to 0.7-1.8m	Controlled Fill: sandy SILT and/or silty SAND with minor to some gravel content, over Sandy GRAVEL Fill.	Observations made during the earthworks.
0.7 to 1.2-1.4m	Insitu silts and sands.	Neighbouring lot Scala penetrometers and earthworks observations.
1.2-1.4m to >10m	Insitu sandy gravels.	Site wide subdivision testing.
