31 August 2018

Our Ref: 419748

Geotechnical and Foundation Report: Lot 28, Manakura Neighbourhood, Karamū Subdivision, Riccarton, Christchurch

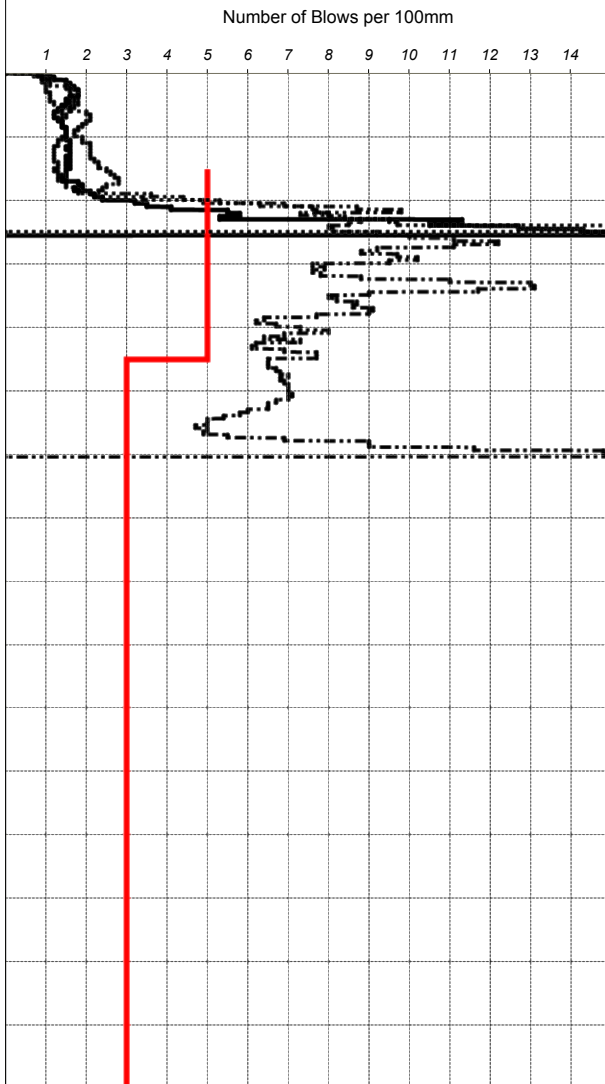
SCALA PENETROMETER TEST RESULTS

Depth (m)	Test Location - Lot 28, A	Water
0.0 - 0.4	FILL: silty TOPSOIL; dark brown. Moist; trace rootlets.	Groundwater Not Encountered
0.4 - 0.6	FILL: silty gravelly SAND; greyish brown. Damp. EOH: 0.5m - Target depth.	
0.6 - 0.7	0.70m: Indicative depth of controlled fill at P03 and A.	Groundwater Not Encountered
0.7 - 0.8	0.80m: Indicative depth of controlled fill at P01.	
0.8 - 0.9	0.90m: Indicative depth of controlled fill at P02.
