26 October 2018

Our Ref: 419748

Geotechnical and Foundation Report: Lot 42, Manakura Neighbourhood, Karamū Subdivision, Riccarton, Christchurch

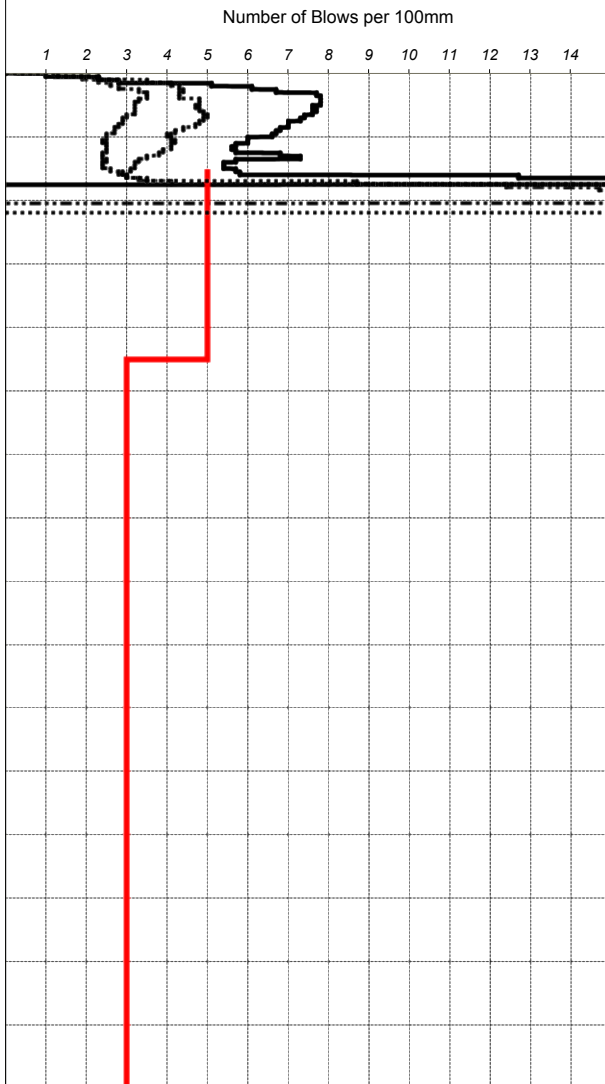
SCALA PENETROMETER TEST RESULTS

Typically, below the topsoil layer the penetrometer test results generally indicate a geotechnical ultimate bearing capacity >300 kPa. Standard foundations for dwellings within the scope of NZS 3604:2011 are suitable. Refer to MBIE Section 5.2 *Overview of new foundations options*.

Minimum penetration resistance (based on 300mm wide footing founded at 300mm depth) required for "Good Ground" as defined in the Acceptable Solutions and Verification Methods for NZBC Clause B1 Structure.

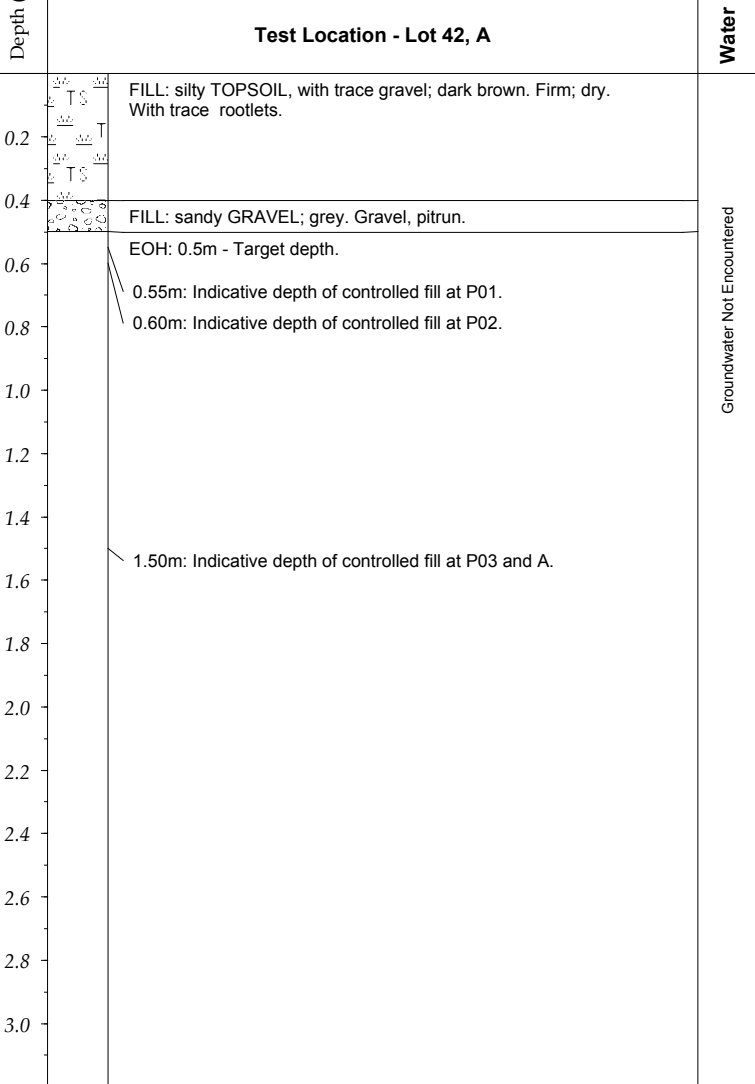
SOIL PROFILE

Depth (Below Ground Level)	Soil Description	Information Source
0m to 0.4m	Silty TOPSOIL FILL.	Spade hole following the earthworks.
0.4m to 0.45-2.2m	Controlled Fill: Imported river-run sandy GRAVEL.	Observations made during the earthworks.
0.45m to ~1.5m	Insitu silts and sands.	Soil log from a nearby test pit and refusal depth from a nearby CPT.
~1.5-2.2m to >10m	Insitu sandy gravels.	Site wide subdivision testing.
