29 August 2018

Our Ref: 419748

Geotechnical and Foundation Report: Lot 13, Manakura Neighbourhood, Karamū Subdivision, Riccarton, Christchurch

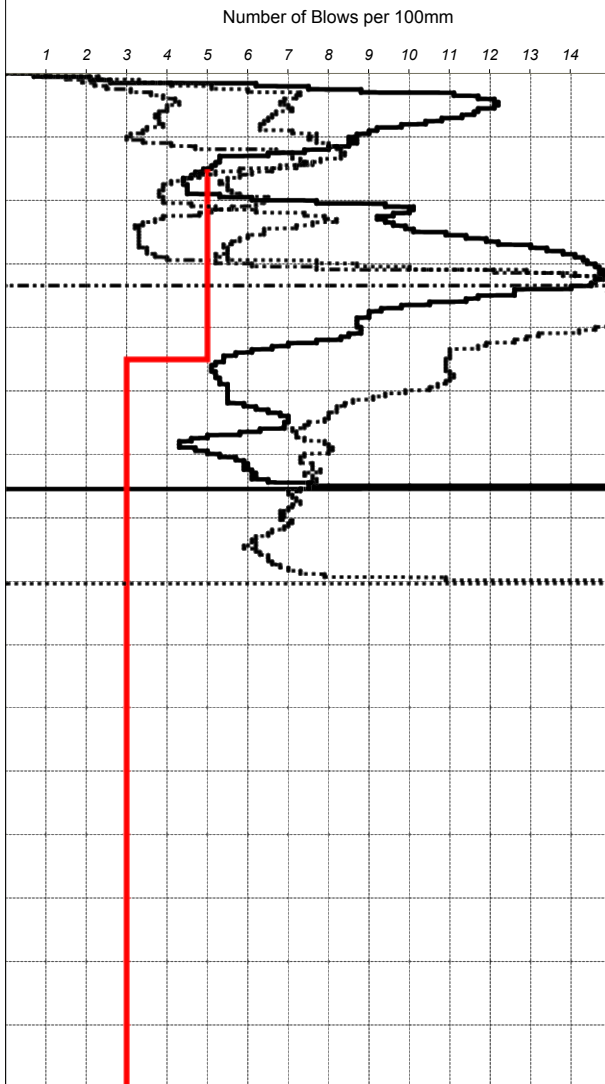
SCALA PENETROMETER TEST RESULTS

Typically, below the topsoil layer the penetrometer test results generally indicate a geotechnical ultimate bearing capacity >300kPa. Penetrometer P02 falls slightly below the NZS3604 definition of “Good Ground” between 0.4 – 0.6m depth. Compaction or proof rolling within a foundation excavation will increase the bearing resistance. Therefore, we consider standard foundations for dwellings within the scope of NZS 3604:2011 are suitable for Lot 13. Refer to MBIE Section 5.2 *Overview of new foundations options*.

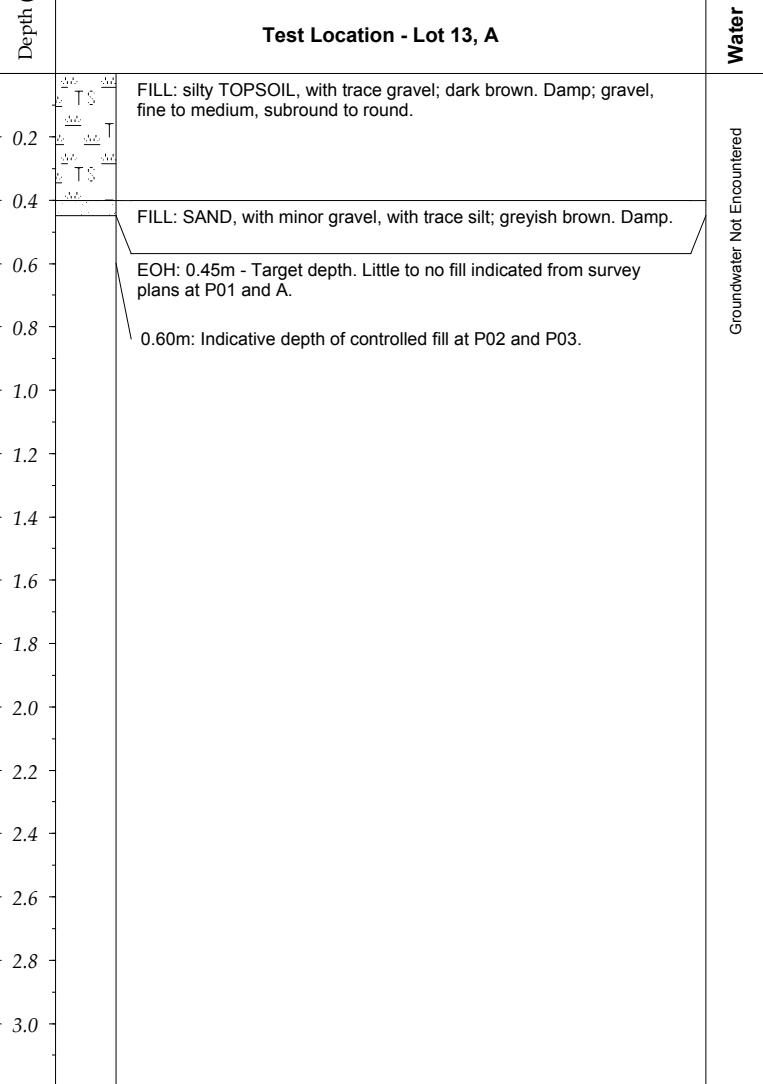
SOIL PROFILE

Depth (Below Ground Level)	Soil Description	Information Source
0m to 0.4m	Silty TOPSOIL FILL.	Spade hole following the earthworks.
0.4m to 0.45-0.6m	Controlled Fill: sandy SILT and/or silty SAND with minor to some gravel content.	Observations made during the earthworks.
0.4-0.6m to 1.3-1.6m	Insitu silts and sands.	Refusal depths from penetrometers.
1.3-1.6m to >10m	Insitu sandy gravels.	Site wide subdivision testing.
