26 October 2018

Our Ref: 419748

Geotechnical and Foundation Report: Lot 41, Manakura Neighbourhood, Karamū Subdivision, Riccarton, Christchurch

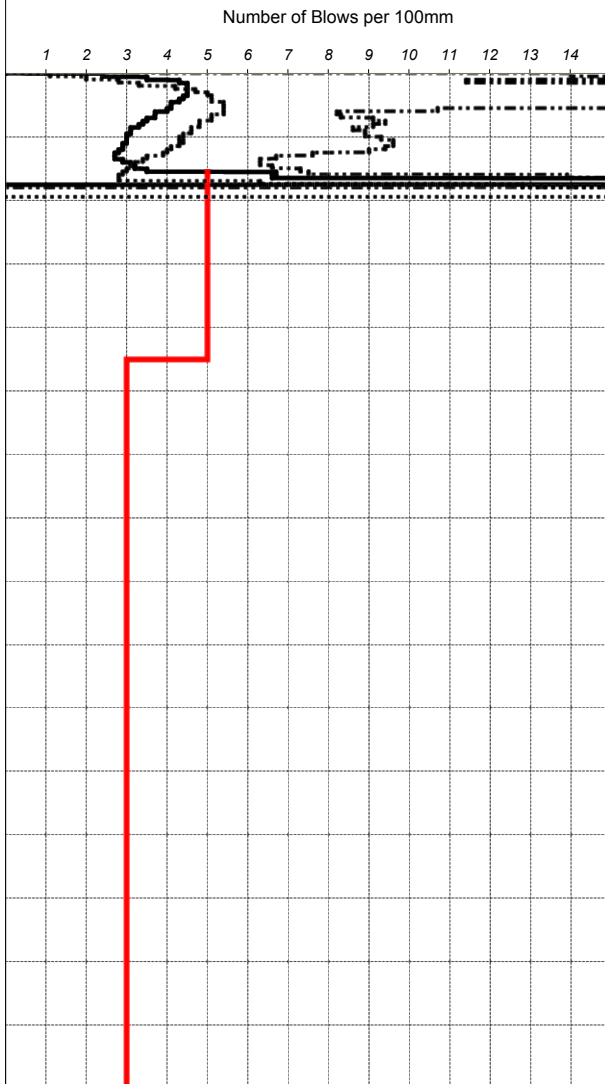
SCALA PENETROMETER TEST RESULTS

Typically, below the topsoil layer the penetrometer test results generally indicate a geotechnical ultimate bearing capacity >300 kPa. Standard foundations for dwellings within the scope of NZS 3604:2011 are suitable. Refer to MBIE Section 5.2 *Overview of new foundations options*.

Minimum penetration resistance (based on 300mm wide footing founded at 300mm depth) required for "Good Ground" as defined in the Acceptable Solutions and Verification Methods for NZBC Clause B1 Structure.

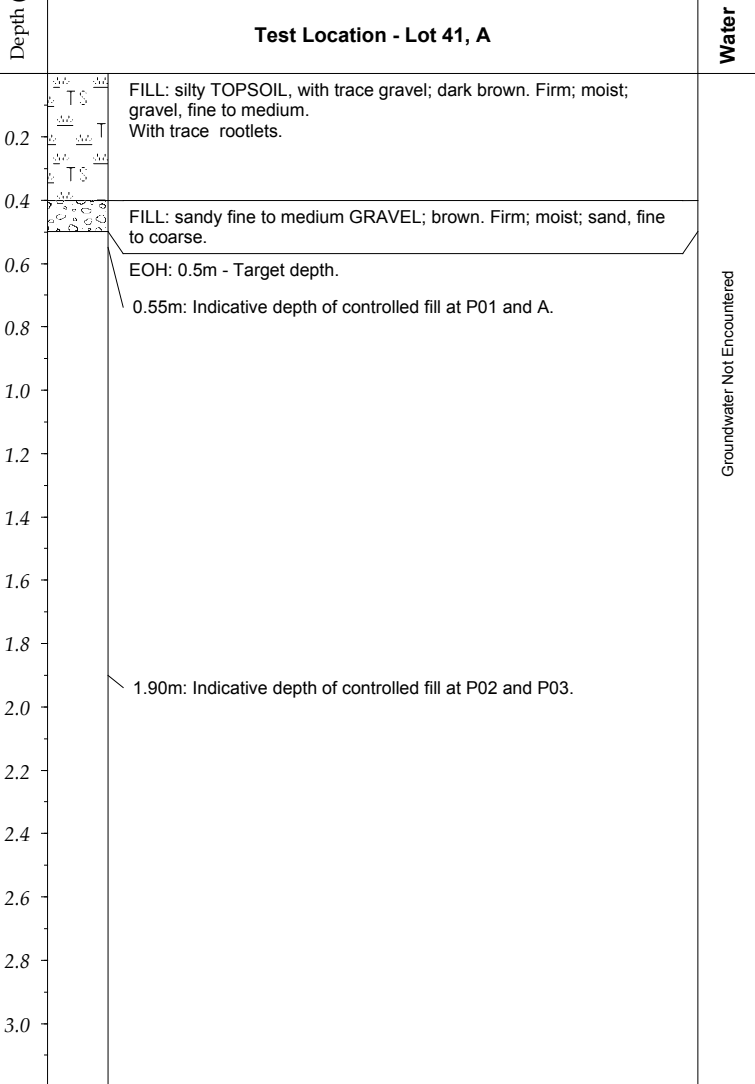
SOIL PROFILE

Table 1 presents the inferred ground profile in Lot 41. The site investigation factual records and test location plans are attached.
