Geotechnical and Foundation Report: Lot 10, Manakura Neighbourhood, Karamū Subdivision, Riccarton, Christchurch

SITE INVESTIGATION RECORD

**Geotechnical Test Locations and Controlled/
Engineered Fill Thickness Contour Plan**

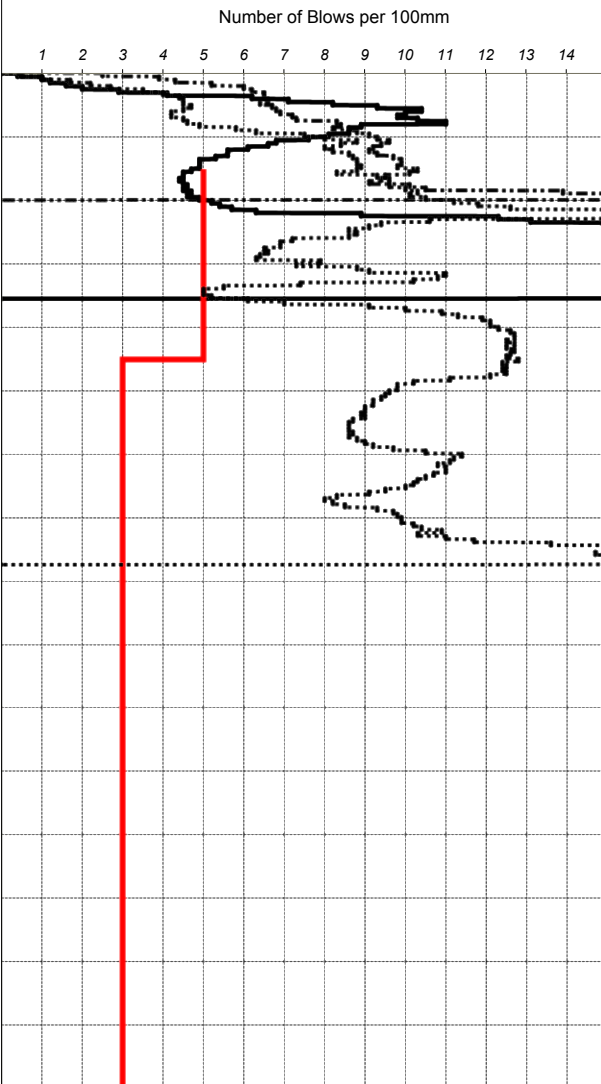
SCALA PENETROMETER TEST RESULTS

Depth (m)	Test Location - Lot 10, A	Water
0.0 - 0.2	FILL: silty TOPSOIL, with some gravel; dark brown. Dry; gravel, round; trace rootlets, (wetter in upper layers).	Groundwater Not Encountered
0.2 - 0.4	FILL: sandy SILT; light brown. Moist.	
0.4 - 3.0	EOH: 0.45m - Target depth. 0.60m: Indicative controlled fill depth at P01. 0.70m: Indicative controlled fill depth at P02, P03 and A.

Scala penetrometers undertaken by Canterbury Geotest Ltd using a Hydraulic penetrometer rig.

Typically, below the topsoil layer the penetrometer test results generally indicate a geotechnical ultimate bearing capacity >300 kPa. Standard foundations for dwellings within the scope of NZS 3604:2011 are suitable. Refer to MBIE Section 5.2 *Overview of new foundations options*.
