**Geotechnical and Foundation Report: Lot 14, Manakura Neighbourhood, Karamū Subdivision, Riccarton, Christchurch**

## SITE INVESTIGATION RECORD

Drawing Title  
**Geotechnical Test Locations and Controlled/ Engineered Fill Thickness Contour Plan**

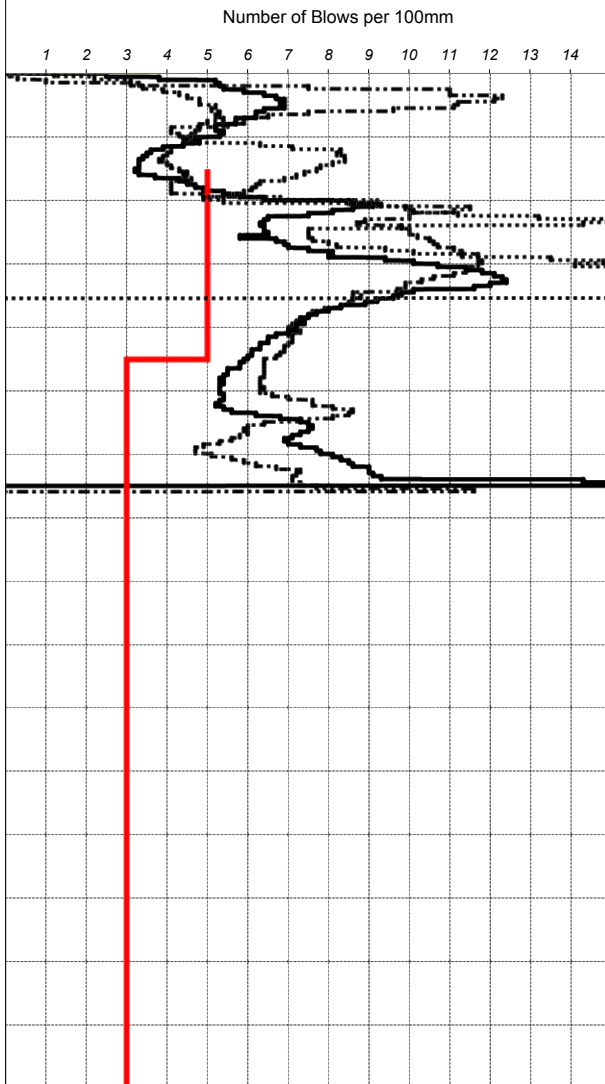
### SCALA PENETROMETER TEST RESULTS

Scala penetrometers undertaken by Canterbury Geotest Ltd using a Hydraulic penetrometer rig.

Typically, below the topsoil layer the penetrometer test results generally indicate a geotechnical ultimate bearing capacity >300 kPa. Standard foundations for dwellings within the scope of NZS 3604:2011 are suitable. Refer to MBIE Section 5.2 *Overview of new foundations options*.
