Geotechnical and Foundation Report: Lot 18, Manakura Neighbourhood, Karamū Subdivision, Riccarton, Christchurch

This report provides the geotechnical appraisal and foundation recommendations for Lot 18 (DP 518068), Manakura Neighbourhood, Karamū Subdivision, Riccarton, Christchurch.

SITE INVESTIGATION RECORD

Drawing Title
Geotechnical Test Locations and Controlled/ Engineered Fill Thickness Contour Plan

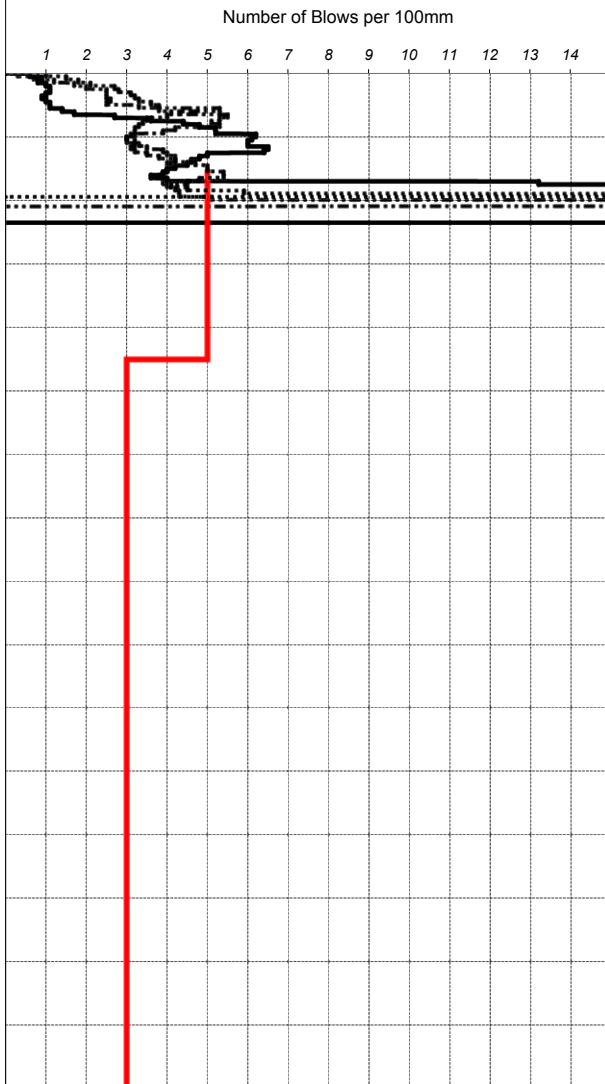
SCALA PENETROMETER TEST RESULTS

Depth (m)	Test Location - Lot 18, A	Water
0.0 - 0.4	FILL: silty TOPSOIL, with trace gravel; dark brown. Damp; trace rootlets, firm.	Groundwater Not Encountered
0.4 - 0.55	Sandy fine to medium GRAVEL; light brown. Sand, medium; Damp.	
0.55 - 3.0	EOH: 0.45m - Target depth. Little to no fill indicated from survey plans at P01. 0.55m: Indicative depth of controlled fill at P02, P03 and A

— Lot 18 P01 - - - Lot 18 P02 ···· Lot 18 P03

Minimum penetration resistance (based on 300mm wide footing founded at 300mm depth) required for "Good Ground" as defined in the Acceptable Solutions and Verification Methods for NZBC Clause B1 Structure.

Scala penetrometers undertaken by Canterbury Geotest Ltd using a Hydraulic penetrometer rig.

Following the completion of the earthworks, we undertook site specific geotechnical testing across all residential lots within the subdivision. Testing within Lot 18 comprised 1 shallow spade hole and 3 hydraulic penetrometers³.

Typically, below the topsoil layer the penetrometer test results generally indicate a geotechnical ultimate bearing capacity >300 kPa. Standard foundations for dwellings within the scope of NZS 3604:2011 are suitable. Refer to MBIE Section 5.2 *Overview of new foundations options*.
