Geotechnical and Foundation Report: Lot 24, Manakura Neighbourhood, Karamū Subdivision, Riccarton, Christchurch

SITE INVESTIGATION RECORD

Drawing Title
Geotechnical Test Locations and Controlled/ Engineered Fill Thickness Contour Plan

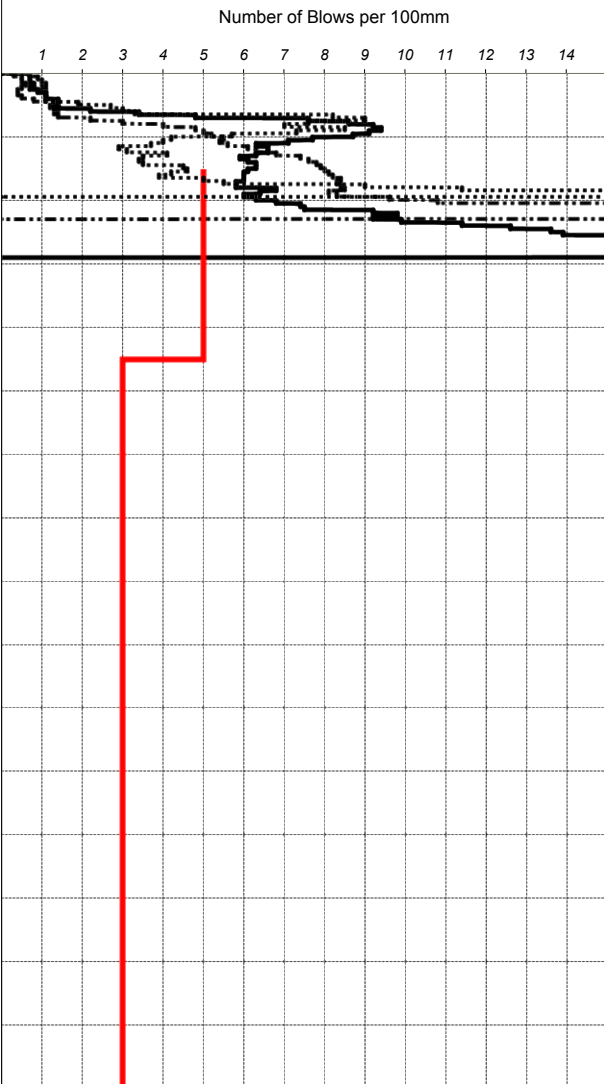
SCALA PENETROMETER TEST RESULTS

— Lot 24 P01 - - - Lot 24 P02 ···· Lot 24 P03

Minimum penetration resistance (based on 300mm wide footing founded at 300mm depth) required for "Good Ground" as defined in the Acceptable Solutions and Verification Methods for NZBC Clause B1 Structure.

Scala penetrometers undertaken by Canterbury Geotest Ltd using a Hydraulic penetrometer rig.

Typically, below the topsoil layer the penetrometer test results generally indicate a geotechnical ultimate bearing capacity >300 kPa. Standard foundations for dwellings within the scope of NZS 3604:2011 are suitable. Refer to MBIE Section 5.2 *Overview of new foundations options*.
