**Geotechnical and Foundation Report: Lot 16, Manakura Neighbourhood, Karamū Subdivision, Riccarton, Christchurch**

This report provides the geotechnical appraisal and foundation recommendations for Lot 16 (DP 518068), Manakura Neighbourhood, Karamū Subdivision, Riccarton, Christchurch.

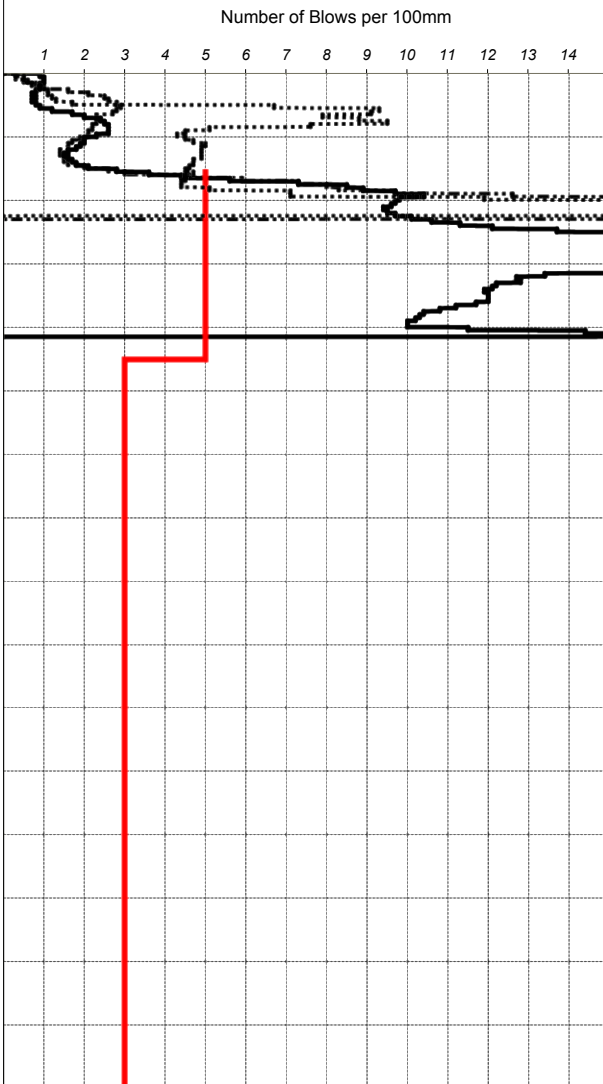
### SCALA PENETROMETER TEST RESULTS

Typically, below the topsoil layer the penetrometer test results generally indicate a geotechnical ultimate bearing capacity >300 kPa. Standard foundations for dwellings within the scope of NZS 3604:2011 are suitable. Refer to MBIE Section 5.2 *Overview of new foundations options*.
