Geotechnical and Foundation Report: Lot 17, Manakura Neighbourhood, Karamū Subdivision, Riccarton, Christchurch

This report provides the geotechnical appraisal and foundation recommendations for Lot 17 (DP 518068), Manakura Neighbourhood, Karamū Subdivision, Riccarton, Christchurch.

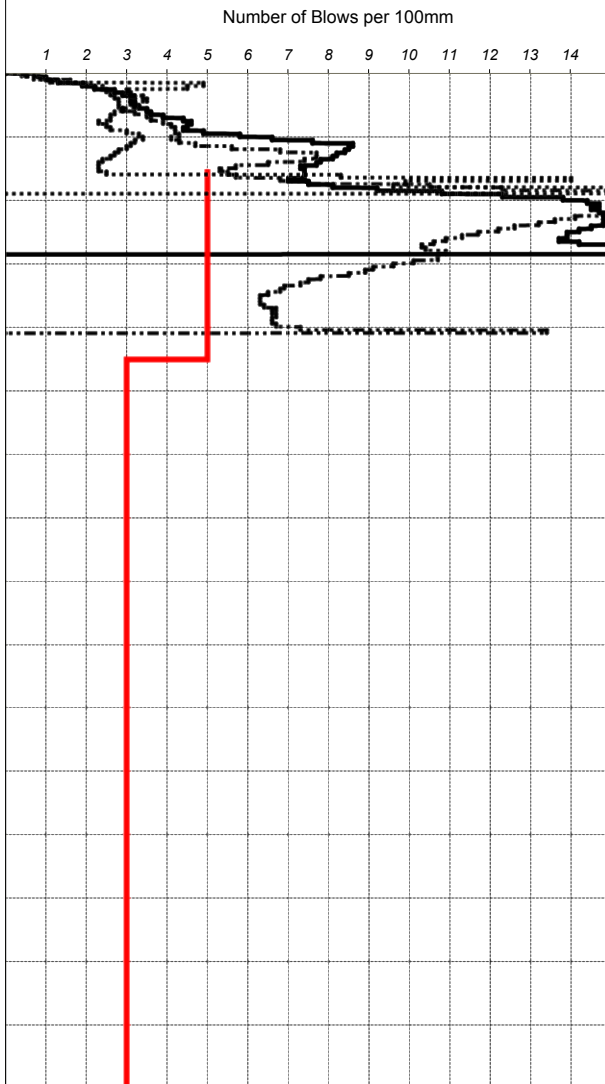
SCALA PENETROMETER TEST RESULTS

Site **Stage 1, Manakura Neighbourhood,
 Karamū Subdivision, Riccarton Park**

SOIL PROFILE

Depth (m)	Test Location - Lot 17, A	Water
0.0 - 0.4	FILL: silty TOPSOIL, with some gravel; dark brown.	Groundwater Not Encountered
0.4 - 0.45	SAND, with some gravel; light brown. Damp.	
0.45 - 3.0	EOH: 0.45m - Target depth. Little to no fill indicated from survey plans at P01, P02, P03 and A.

Typically, below the topsoil layer the penetrometer test results generally indicate a geotechnical ultimate bearing capacity >300 kPa. Standard foundations for dwellings within the scope of NZS 3604:2011 are suitable. Refer to MBIE Section 5.2 *Overview of new foundations options*.
