**Geotechnical and Foundation Report: Lot 19, Manakura Neighbourhood, Karamū Subdivision, Riccarton, Christchurch**

This report provides the geotechnical appraisal and foundation recommendations for Lot 19 (DP 518068), Manakura Neighbourhood, Karamū Subdivision, Riccarton, Christchurch.

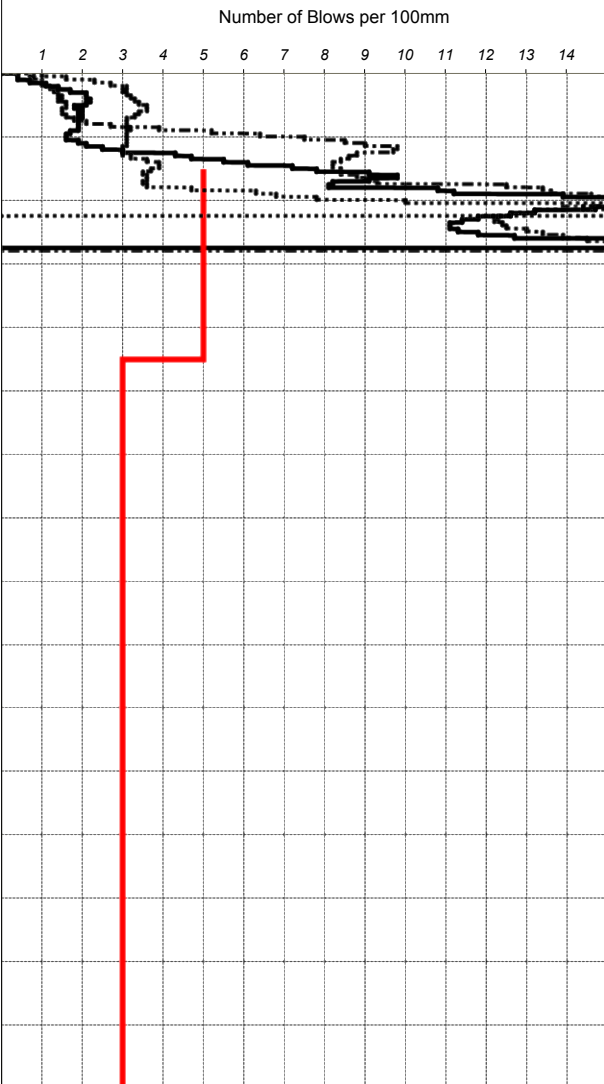
### SCALA PENETROMETER TEST RESULTS

Depth (m)	Test Location - Lot 19, A	Water
0.0 - 0.2	FILL: silty TOPSOIL, with some gravel; dark brown. Soft; wet. 0.20m: Becoming damp, firm.	Groundwater Not Encountered
0.2 - 0.4	FILL: sandy fine to medium GRAVEL; light brown. Damp.	
0.4 - 0.5	EOH: 0.45m - Target depth. Little to no fill indicated from survey plans at P01, P02 and A. 0.50m: Indicative depth of controlled fill at P03.

Typically, below the topsoil layer the penetrometer test results generally indicate a geotechnical ultimate bearing capacity >300 kPa. Standard foundations for dwellings within the scope of NZS 3604:2011 are suitable. Refer to MBIE Section 5.2 *Overview of new foundations options*.
