Geotechnical and Foundation Report: Lot 20, Manakura Neighbourhood, Karamū Subdivision, Riccarton, Christchurch

This report provides the geotechnical appraisal and foundation recommendations for Lot 20 (DP 518068), Manakura Neighbourhood, Karamū Subdivision, Riccarton, Christchurch.

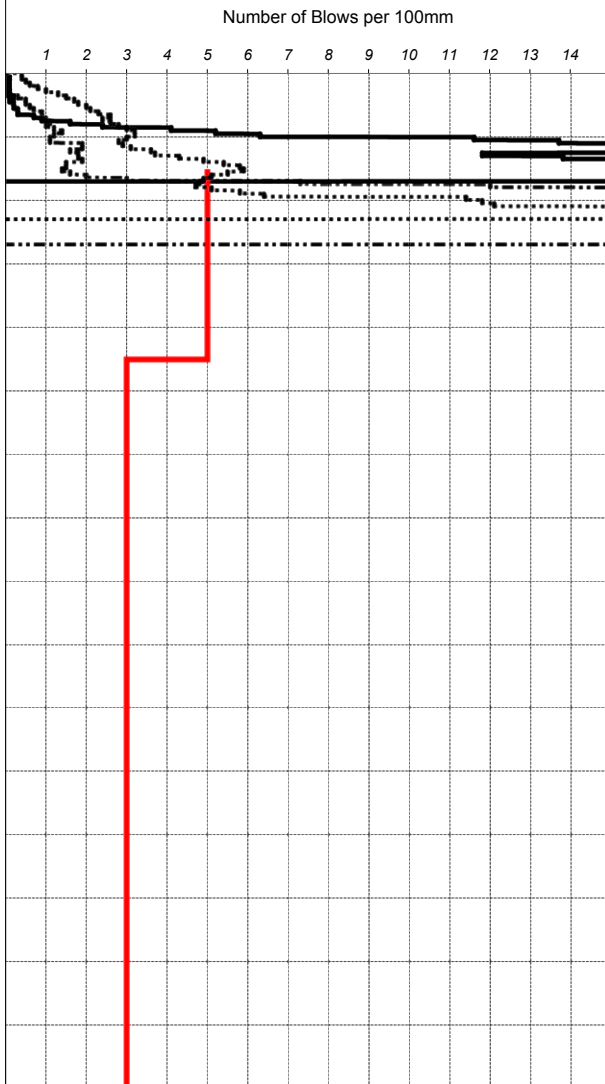
SCALA PENETROMETER TEST RESULTS

Depth (m)	Test Location - Lot 20, A	Water
0.0 - 0.2	FILL: silty TOPSOIL, with minor gravel; dark brown. Damp; trace rootlets.	Groundwater Not Encountered
0.2 - 0.4	FILL: sandy fine to medium GRAVEL; light brown. Damp.	
0.4 - 0.6	EOH: 0.45m - Target depth. Little to no fill indicated from survey plans at P01.	
0.6 - 0.8	0.50m: Indicative depth of controlled fill at P03. 0.65m: Indicative depth of controlled fill at P02 and A.	
0.8 - 3.0

Typically, below the topsoil layer the penetrometer test results generally indicate a geotechnical ultimate bearing capacity >300 kPa. Standard foundations for dwellings within the scope of NZS 3604:2011 are suitable. Refer to MBIE Section 5.2 *Overview of new foundations options*.
