Geotechnical and Foundation Report: Lot 22, Manakura Neighbourhood, Karamū Subdivision, Riccarton, Christchurch

This report provides the geotechnical appraisal and foundation recommendations for Lot 22 (DP 518068), Manakura Neighbourhood, Karamū Subdivision, Riccarton, Christchurch.

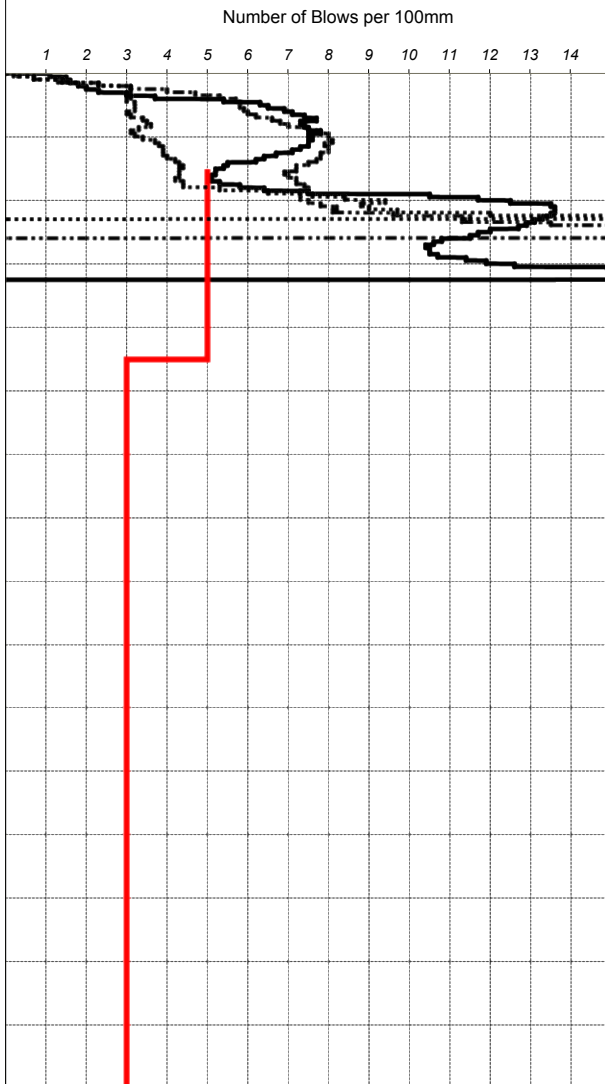
SCALA PENETROMETER TEST RESULTS

Depth (m)	Test Location - Lot 22, A	Water
0.2	FILL: silty TOPSOIL; dark brown. Damp; trace light brown silt, trace rootlets.	Groundwater Not Encountered
0.4	FILL: sandy SILT, with trace gravel; light brown. Damp.	
0.6	EOH: 0.5m - Target depth. Little to no fill indicated from survey plans at P01, P02 and A. 0.50m: Indicative depth of controlled fill at P03.

Typically, below the topsoil layer the penetrometer test results generally indicate a geotechnical ultimate bearing capacity >300 kPa. Standard foundations for dwellings within the scope of NZS 3604:2011 are suitable. Refer to MBIE Section 5.2 *Overview of new foundations options*.
