**Geotechnical and Foundation Report: Lot 25, Manakura Neighbourhood, Karamū Subdivision, Riccarton, Christchurch**

This report provides the geotechnical appraisal and foundation recommendations for Lot 25 (DP 518068), Manakura Neighbourhood, Karamū Subdivision, Riccarton, Christchurch.

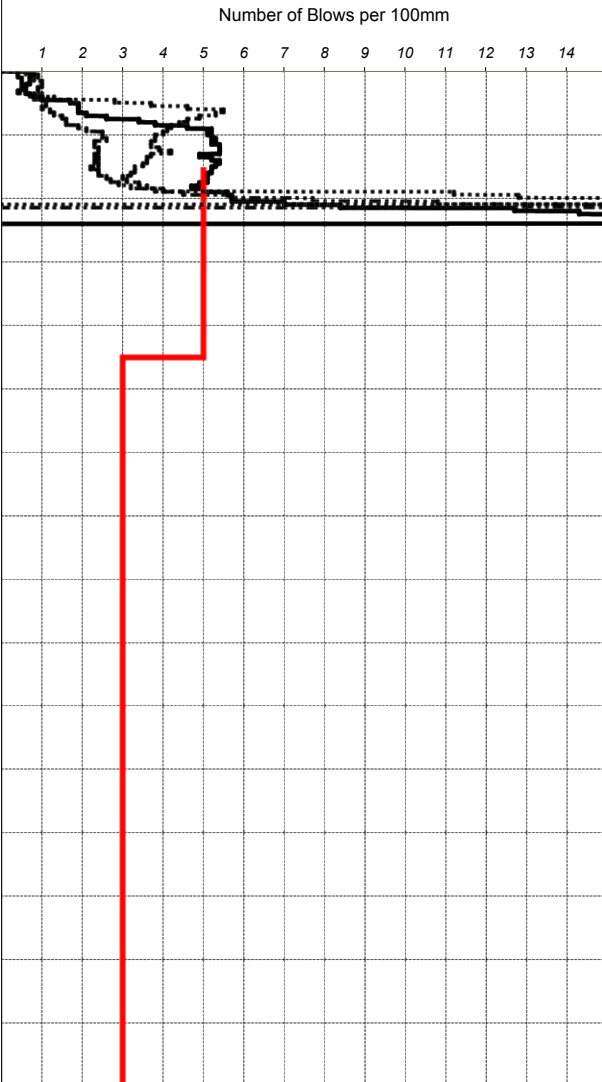
### SCALA PENETROMETER TEST RESULTS

Depth (m)	Test Location - Lot 25, A	Water
0.0 - 0.2	FILL: silty TOPSOIL; dark brown. Damp; traces of rootlets, (upper 100mm saturated).	Groundwater Not Encountered
0.2 - 0.3	0.30m: Minor patch of organic material.	
0.3 - 0.45	FILL: GRAVEL; brown . Moist.	
0.45 - 0.8	EOH: 0.45m - Target depth. Little to no fill indicated from survey plans at P01.	
0.8 - 1.0	0.80m: Indicative depth of controlled fill at P03 and A.	
1.0 - 3.0	1.00m: Indicative depth of controlled fill at P02.

Typically, below the topsoil layer the penetrometer test results generally indicate a geotechnical ultimate bearing capacity >300 kPa. Standard foundations for dwellings within the scope of NZS 3604:2011 are suitable. Refer to MBIE Section 5.2 *Overview of new foundations options*.
