Our Ref: 419748

Geotechnical and Foundation Report: Lot 37, Manakura Neighbourhood, Karamū Subdivision, Riccarton, Christchurch

This report provides the geotechnical appraisal and foundation recommendations for Lot 37 (DP 518070), Manakura Neighbourhood, Karamū Subdivision, Riccarton, Christchurch.

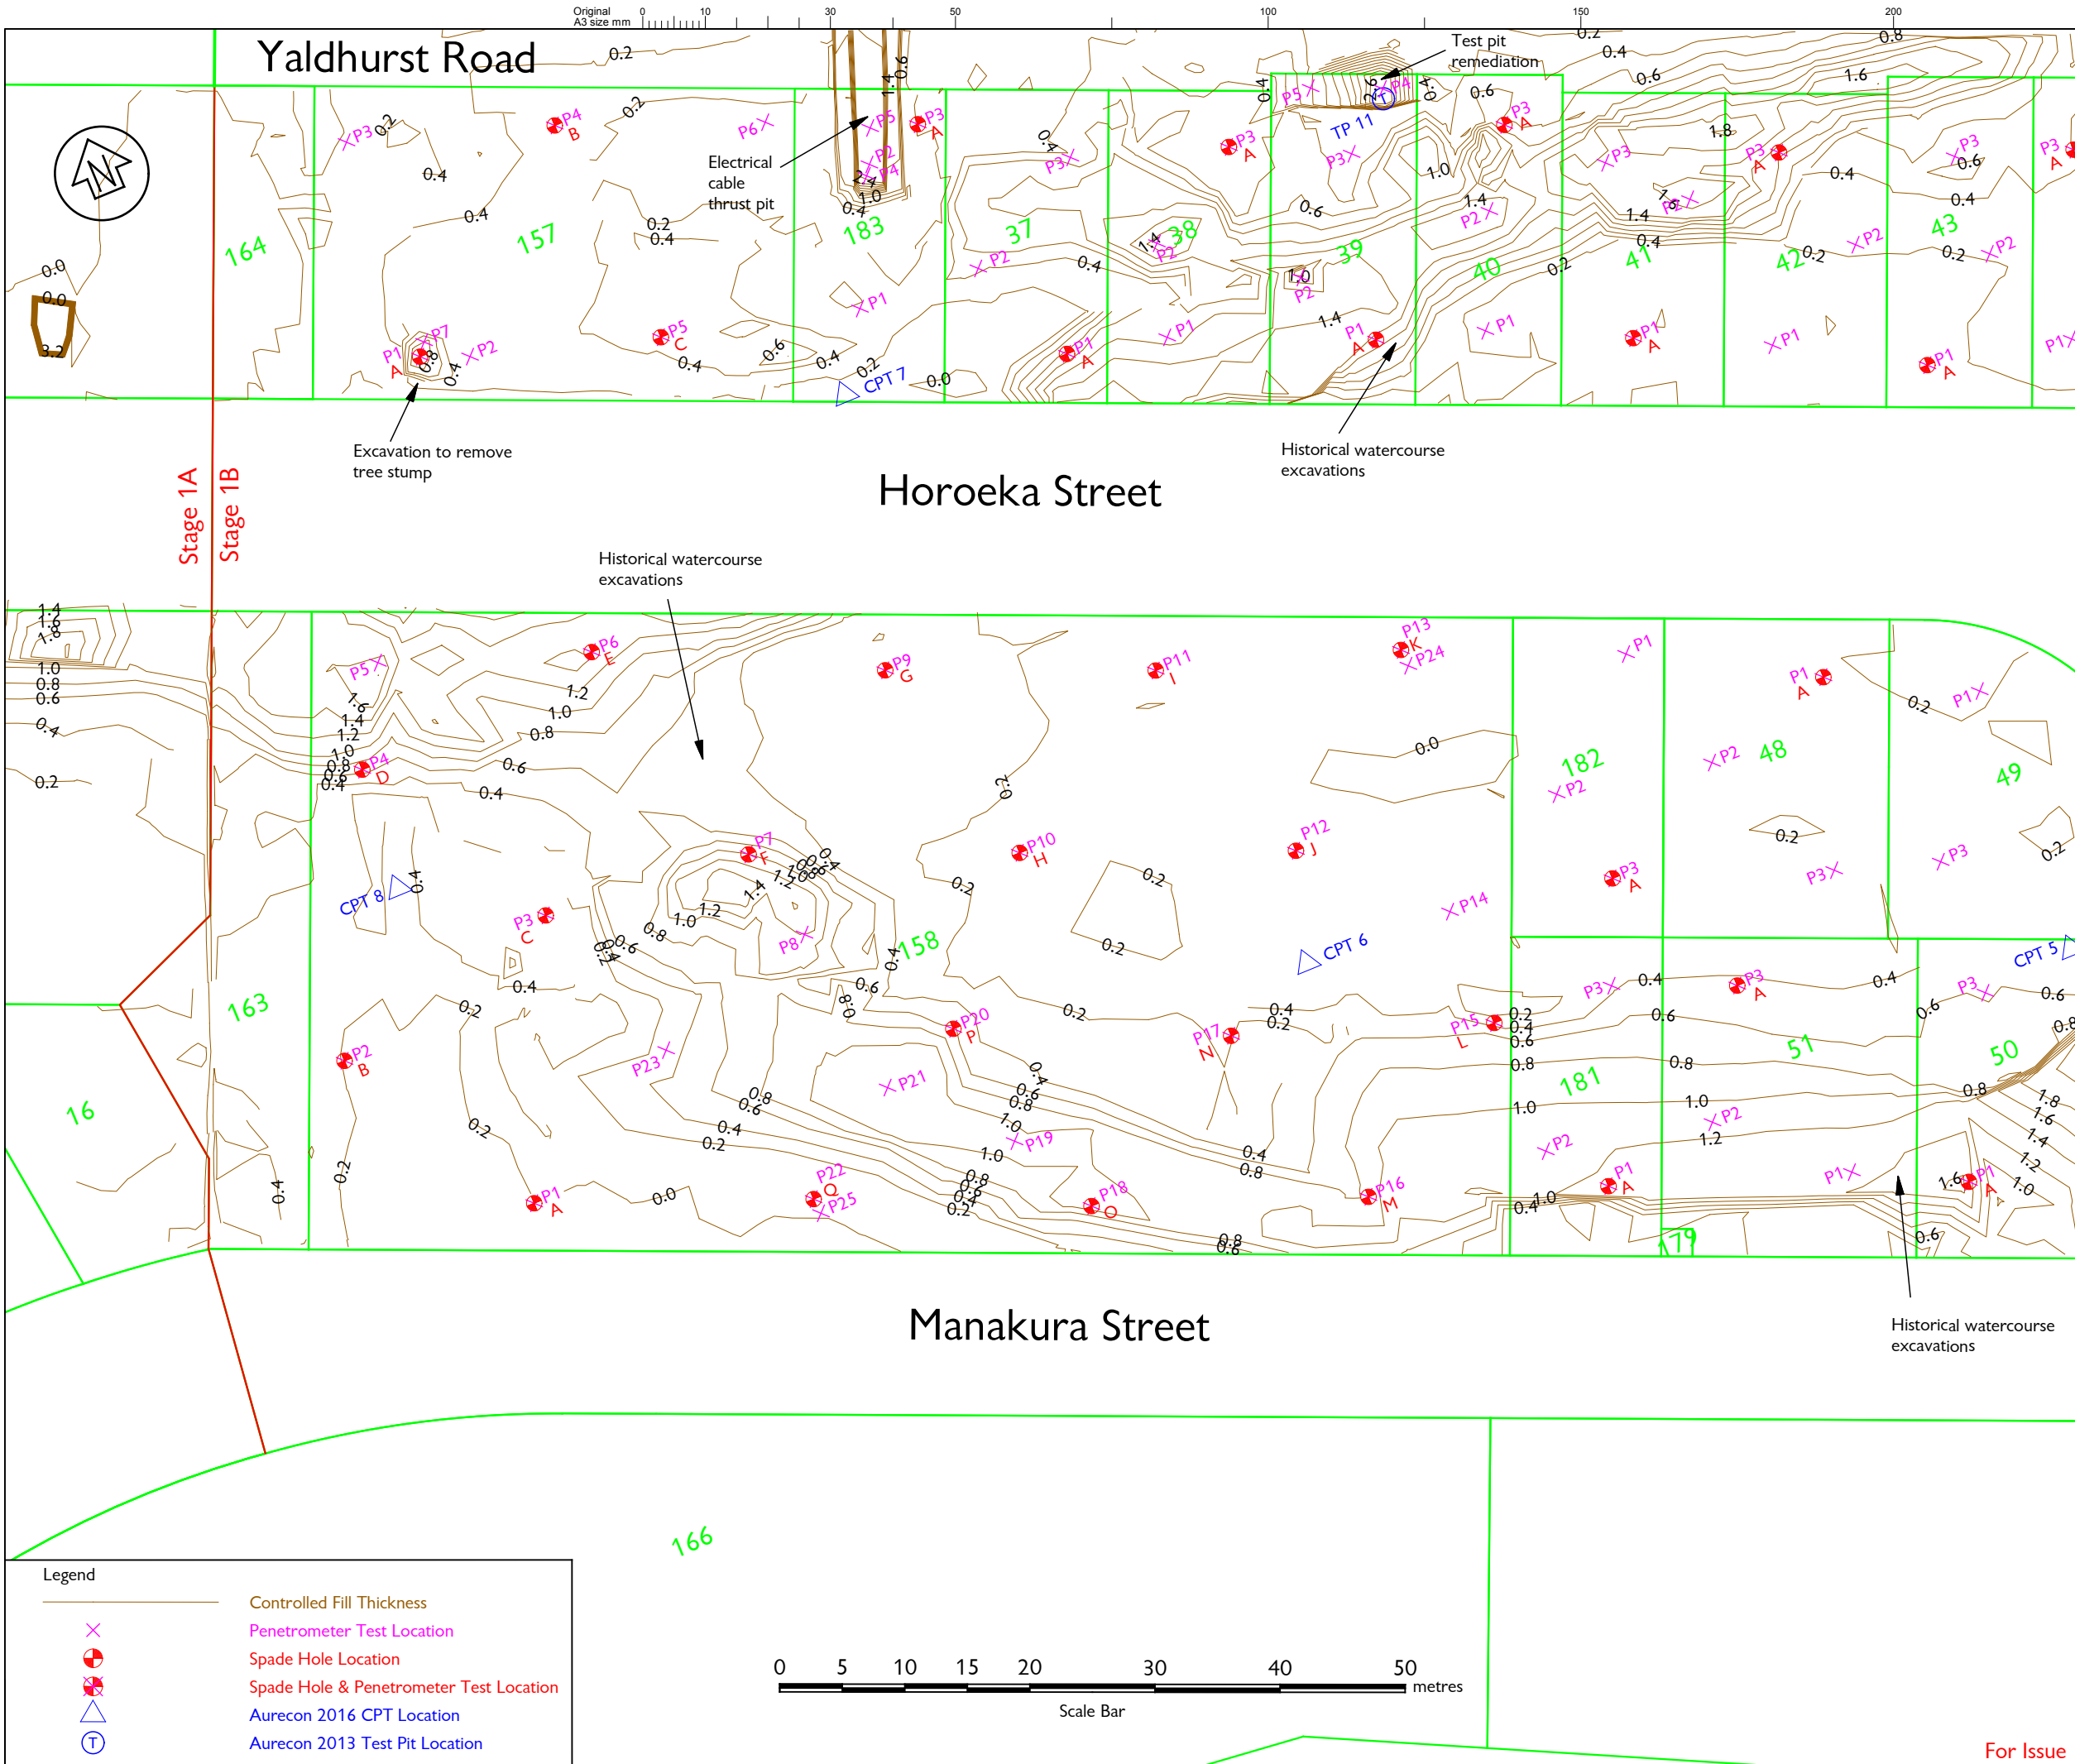
Investigation Type

- Hand Auger
 Spade Hole
 Test Pit

Notes:
 1) The Aurecon test locations shown have been sourced from Aurecon New Zealand Limited - Champions Mile Geotechnical Investigation Report, Dated 23 September 2016. The coordinates of test locations have not been confirmed or verified by Eliot Sinclair.

Refer to Eliot Sinclair & Partners drawing "Geotechnical Test Locations with Controlled Fill Thickness Contours Excluding Topsoil"; Project No. 419748, Set No. G11, Sht No. 1 or 2, Rev. A.
