**Geotechnical and Foundation Report: Lot 38, Manakura Neighbourhood, Karamū Subdivision, Riccarton, Christchurch**

This report provides the geotechnical appraisal and foundation recommendations for Lot 38 (DP 518070), Manakura Neighbourhood, Karamū Subdivision, Riccarton, Christchurch.

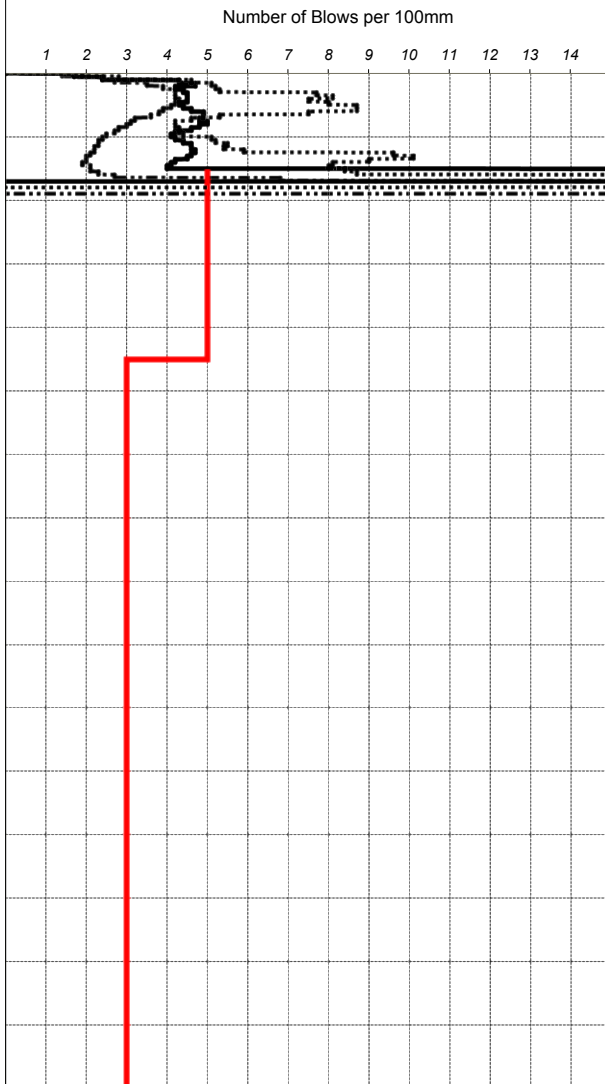
### SCALA PENETROMETER TEST RESULTS

— Lot 38, P01    - - - Lot 38, P02    ···· Lot 38, P03

Minimum penetration resistance (based on 300mm wide footing founded at 300mm depth) required for "Good Ground" as defined in the Acceptable Solutions and Verification Methods for NZBC Clause B1 Structure.

Typically, below the topsoil layer the penetrometer test results generally indicate a geotechnical ultimate bearing capacity >300 kPa. Standard foundations for dwellings within the scope of NZS 3604:2011 are suitable. Refer to MBIE Section 5.2 *Overview of new foundations options*.

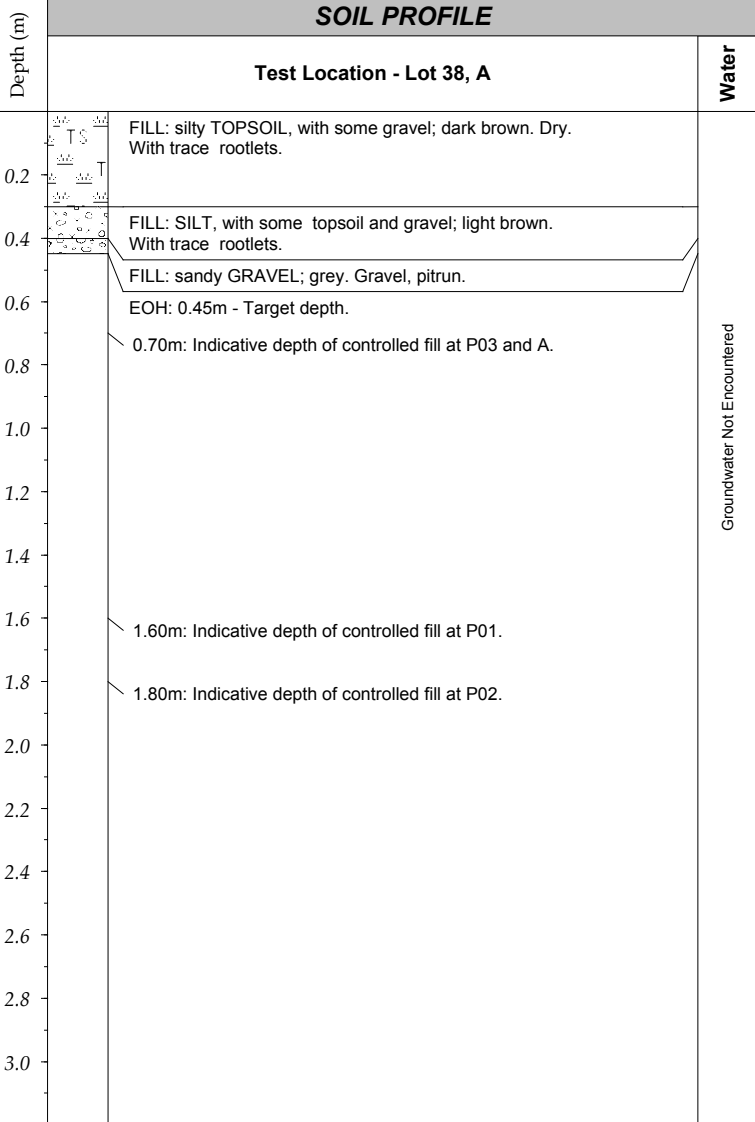
### SOIL PROFILE

Penetrometers undertaken by Canterbury Geotest Ltd using their Hydraulic penetrometer rig.
