Our Ref: 419748

Geotechnical and Foundation Report: Lot 43, Manakura Neighbourhood, Karamū Subdivision, Riccarton, Christchurch

Technical Category
TC1 Equivalent

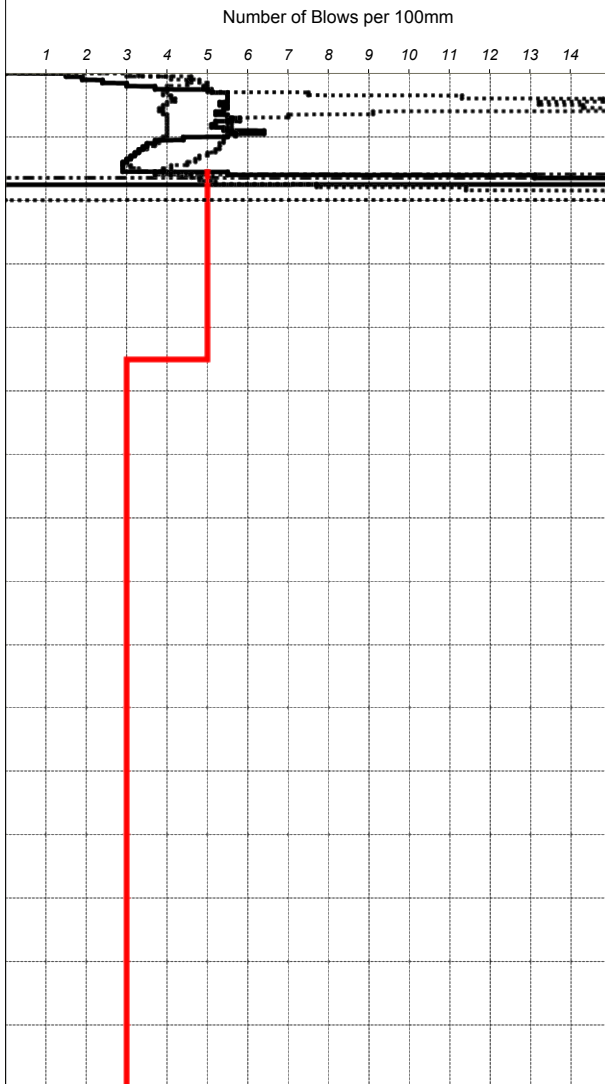
SCALA PENETROMETER TEST RESULTS

Depth (m)	Test Location - Lot 43, A	Water
0.0 - 0.2	FILL: silty TOPSOIL, with trace gravel; dark brown. Firm; moist; gravel, fine to medium.	Groundwater Not Encountered
0.2 - 0.4	FILL: sandy fine to medium GRAVEL; greyish brown. Firm; moist; sand, fine to medium.	
0.4 - 0.6	EOH: 0.45m - Target depth. 0.55m: Indicative depth of controlled fill at P01 and A.	
0.6 - 1.0	0.60m: Indicative depth of controlled fill at P02. 1.00m: Indicative depth of controlled fill at P03.

— Lot 43, P01 - - - Lot 43, P02 ····· Lot 43, P03

Minimum penetration resistance (based on 300mm wide footing founded at 300mm depth) required for "Good Ground" as defined in the Acceptable Solutions and Verification Methods for NZBC Clause B1 Structure.

Typically, below the topsoil layer the penetrometer test results generally indicate a geotechnical ultimate bearing capacity >300 kPa. Standard foundations for dwellings within the scope of NZS 3604:2011 are suitable. Refer to MBIE Section 5.2 *Overview of new foundations options*.
