Geotechnical and Foundation Report: Lot 44, Manakura Neighbourhood, Karamū Subdivision, Riccarton, Christchurch

Technical Category
TC1 Equivalent

SCALA PENETROMETER TEST RESULTS

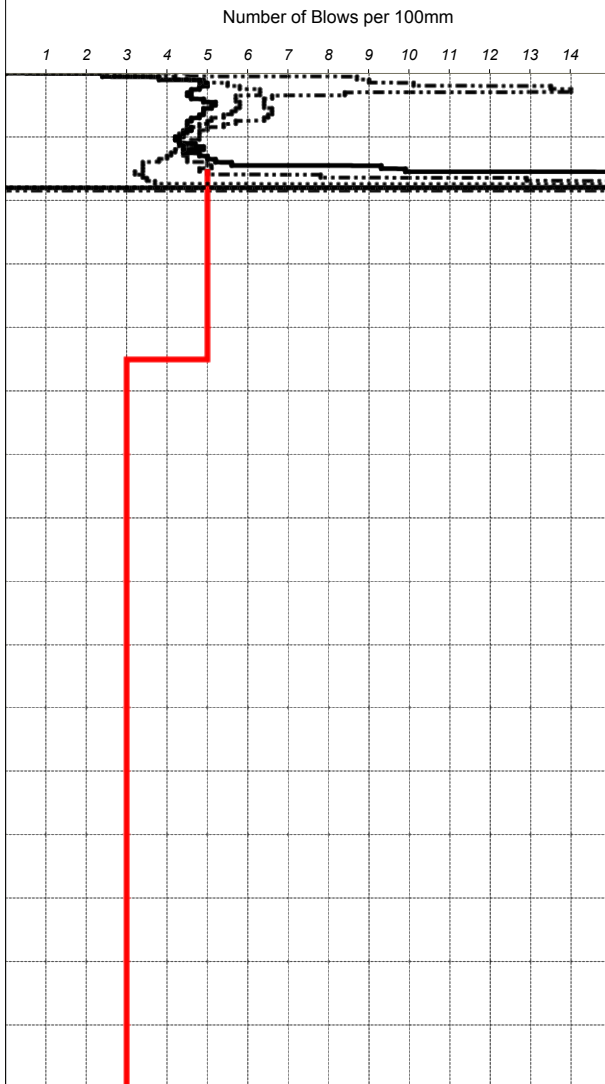
Depth (m)	Test Location - Lot 44, A	Water
0.0 - 0.2	FILL: silty TOPSOIL, with trace gravel; dark brown. Dry. With trace rootlets and silt; light brown.	Groundwater Not Encountered
0.2 - 0.4	FILL: sandy GRAVEL; grey. Dense; gravel, pitrun.	
0.4 - 0.5	EOH: 0.5m - Target depth.	
0.70m	Indicative depth of controlled fill at P01.	
0.80m	Indicative depth of controlled fill at P03 and A.	
1.00m	Indicative depth of controlled fill at P02.

— Lot 44, P01 - - - Lot 44, P02 ···· Lot 44, P03

Minimum penetration resistance (based on 300mm wide footing founded at 300mm depth) required for "Good Ground" as defined in the Acceptable Solutions and Verification Methods for NZBC Clause B1 Structure.

Typically, below the topsoil layer the penetrometer test results generally indicate a geotechnical ultimate bearing capacity >300 kPa. Standard foundations for dwellings within the scope of NZS 3604:2011 are suitable. Refer to MBIE Section 5.2 *Overview of new foundations options*.

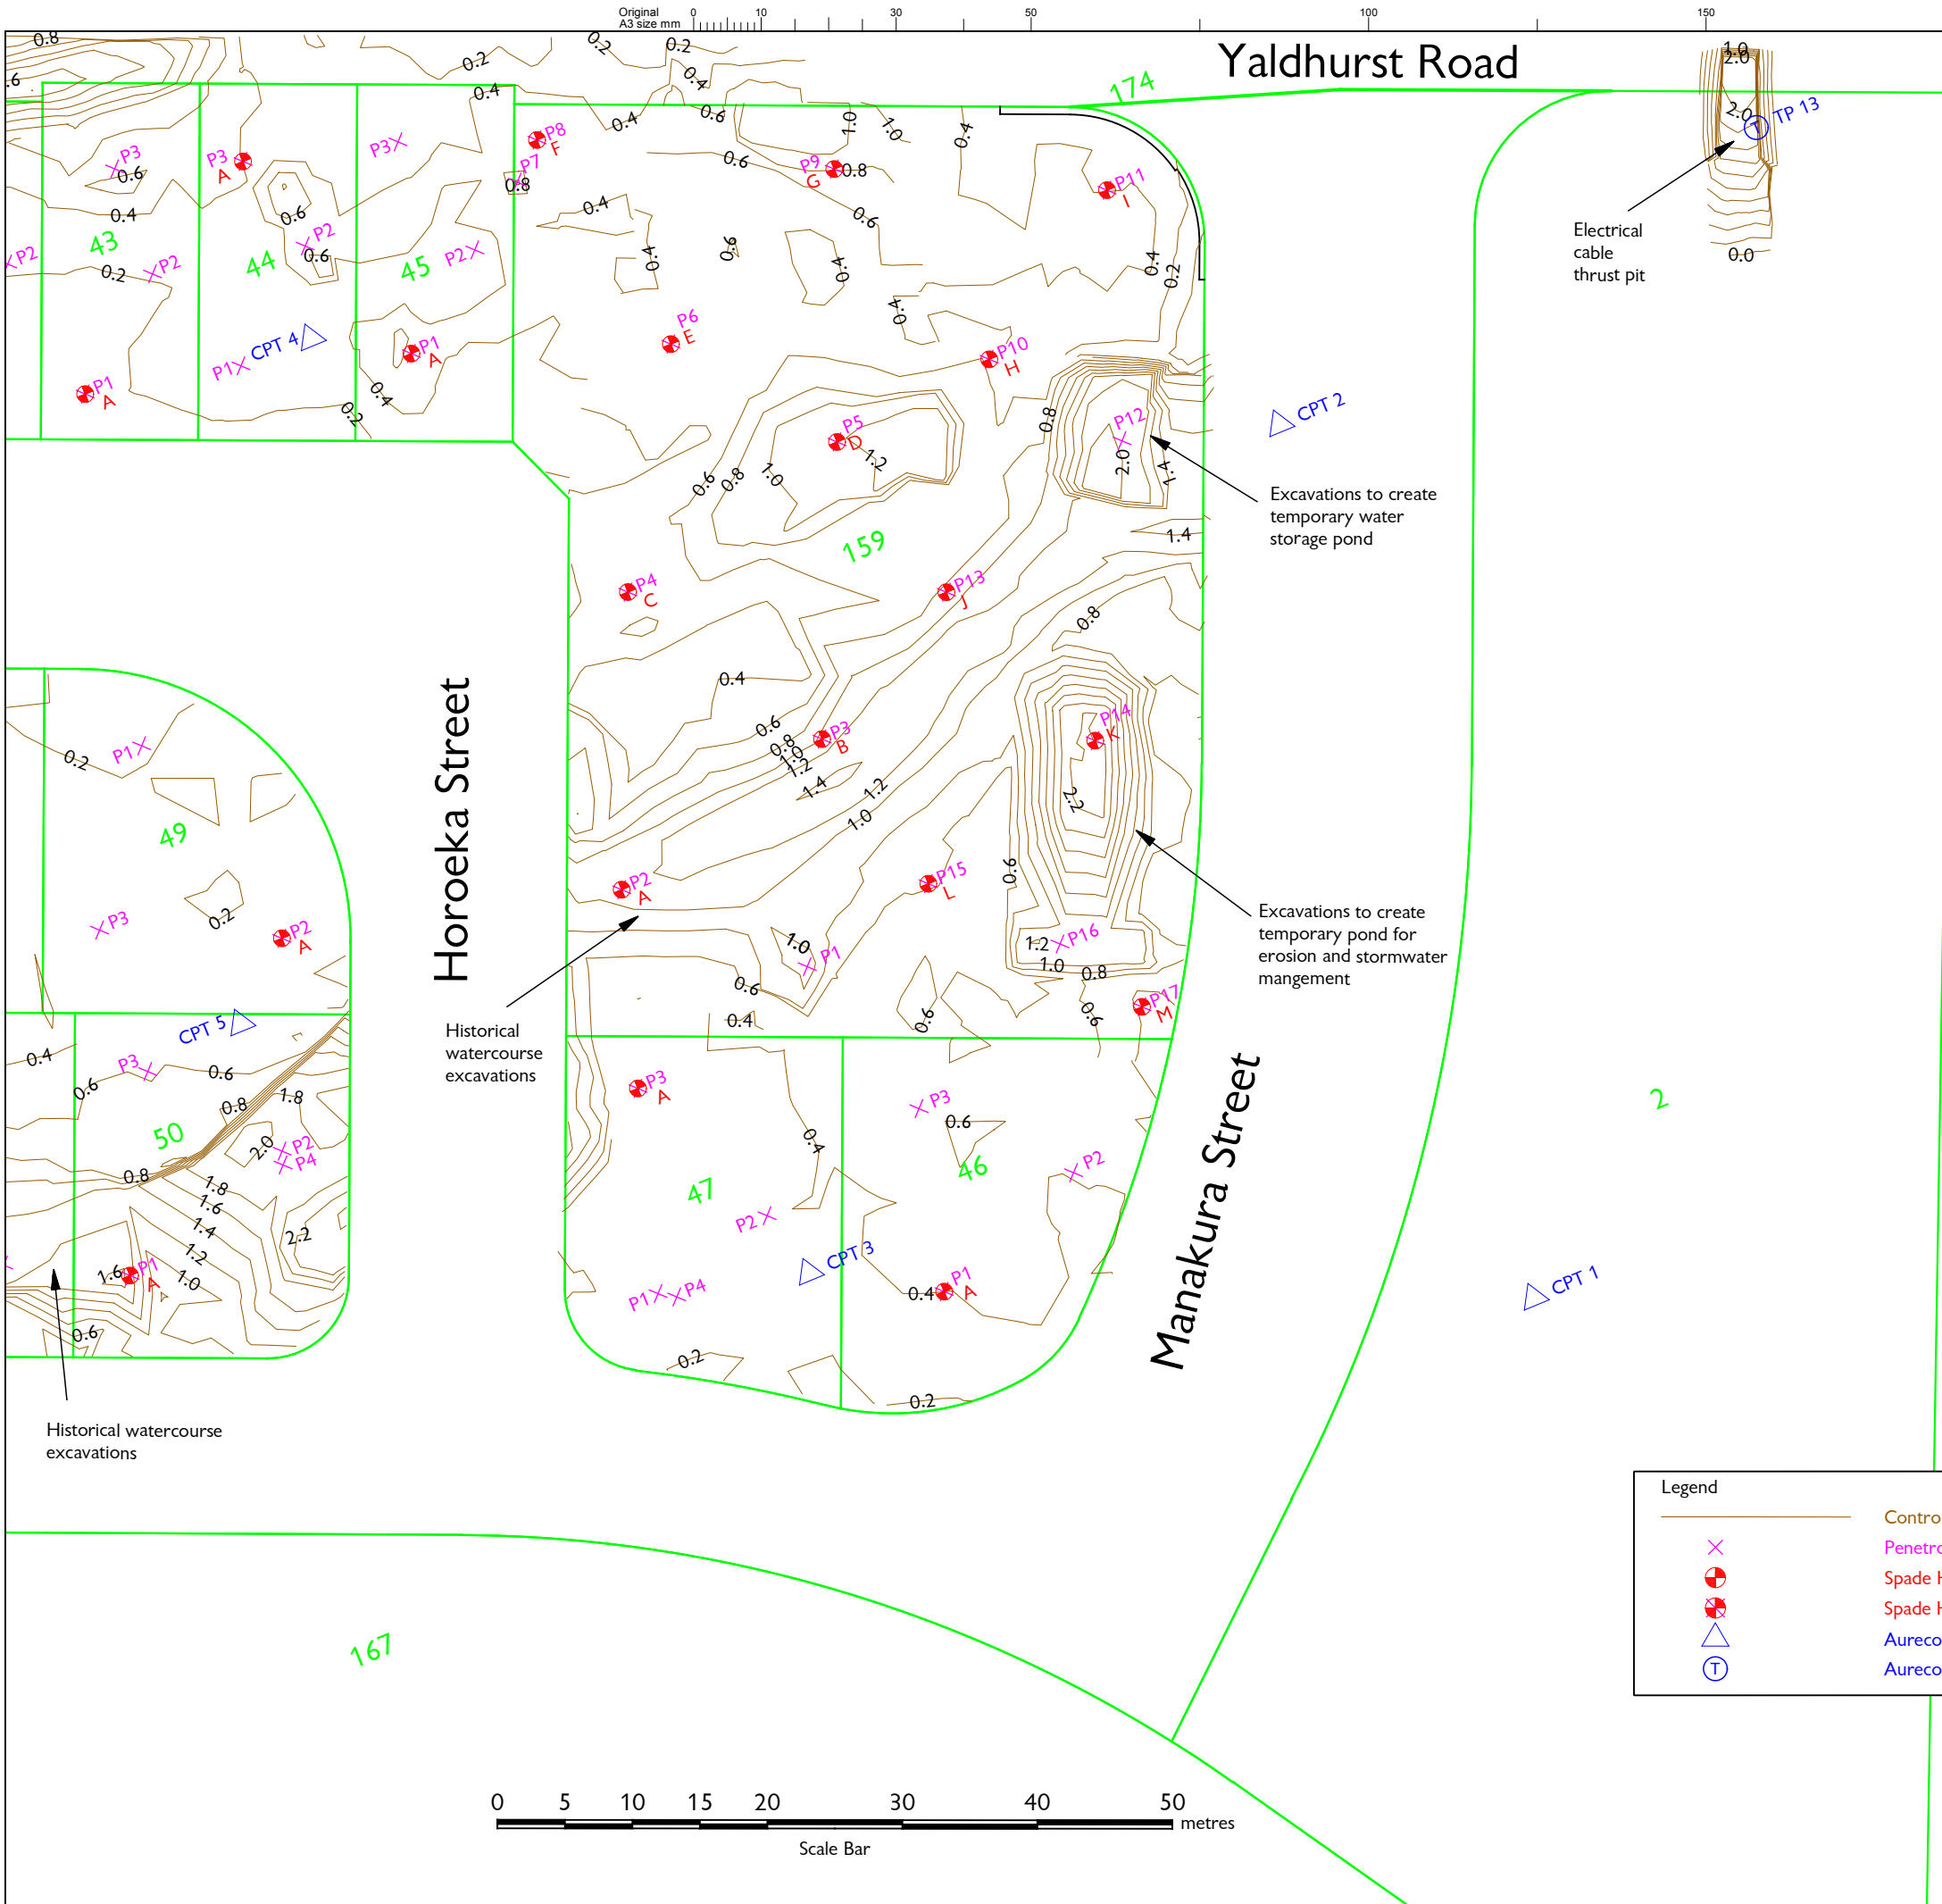
Notes:
 1) The Aurecon test locations shown have been sourced from Aurecon New Zealand Limited - Champions Mile Geotechnical Investigation Report, Dated 23 September 2016. The coordinates of test locations have not been confirmed or verified by Eliot Sinclair.
