**Geotechnical and Foundation Report: Lot 9, Manakura Neighbourhood, Karamū Subdivision, Riccarton, Christchurch**

This report provides the geotechnical appraisal and foundation recommendations for Lot 9 (DP 518068), Manakura Neighbourhood, Karamū Subdivision, Riccarton, Christchurch.

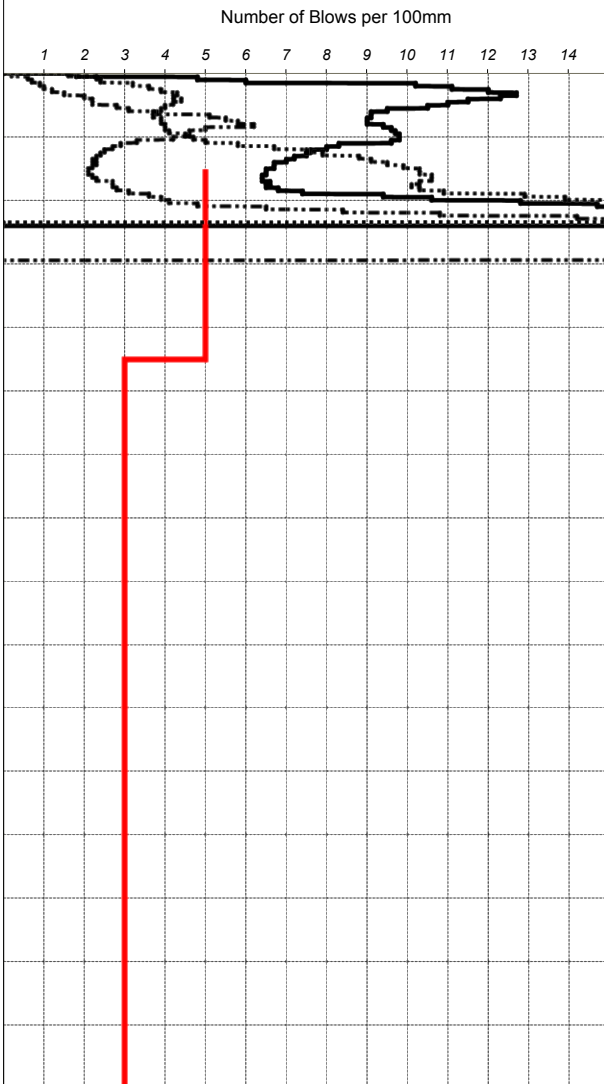
### SCALA PENETROMETER TEST RESULTS

Scala penetrometers undertaken by Canterbury Geotest Ltd using a Hydraulic penetrometer rig.

Typically, below the topsoil layer the penetrometer test results generally indicate a geotechnical ultimate bearing capacity >300 kPa. Standard foundations for dwellings within the scope of NZS 3604:2011 are suitable. Refer to MBIE Section 5.2 *Overview of new foundations options*.
