29 August 2018

Our Ref: 419748

Geotechnical and Foundation Report: Lot 12, Manakura Neighbourhood, Karamū Subdivision, Riccarton, Christchurch

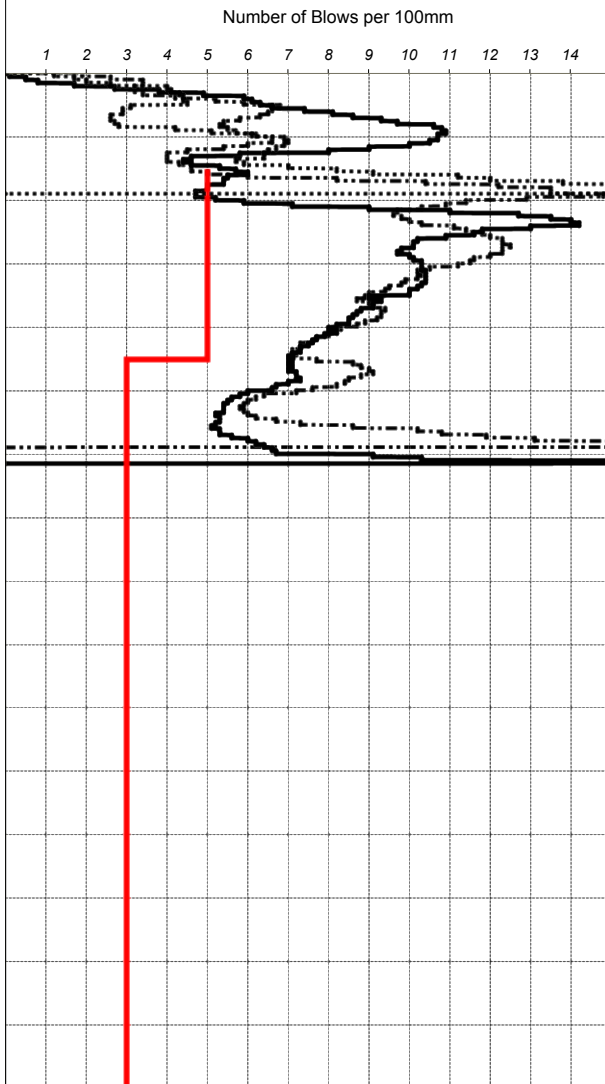
SCALA PENETROMETER TEST RESULTS

Following the completion of the earthworks, we undertook site specific geotechnical testing across all residential lots within the subdivision. Testing within Lot 12 comprised 1 shallow spade hole and 3 hydraulic penetrometers³.

Scala penetrometers undertaken by Canterbury Geotest Ltd using a Hydraulic penetrometer rig.

Typically, below the topsoil layer the penetrometer test results generally indicate a geotechnical ultimate bearing capacity >300 kPa. Standard foundations for dwellings within the scope of NZS 3604:2011 are suitable. Refer to MBIE Section 5.2 *Overview of new foundations options*.
