**Geotechnical and Foundation Report: Lot 15, Manakura Neighbourhood, Karamū Subdivision, Riccarton, Christchurch**

## SITE INVESTIGATION RECORD

Drawing Title  
**Geotechnical Test Locations and Controlled/  
Engineered Fill Thickness Contour Plan**

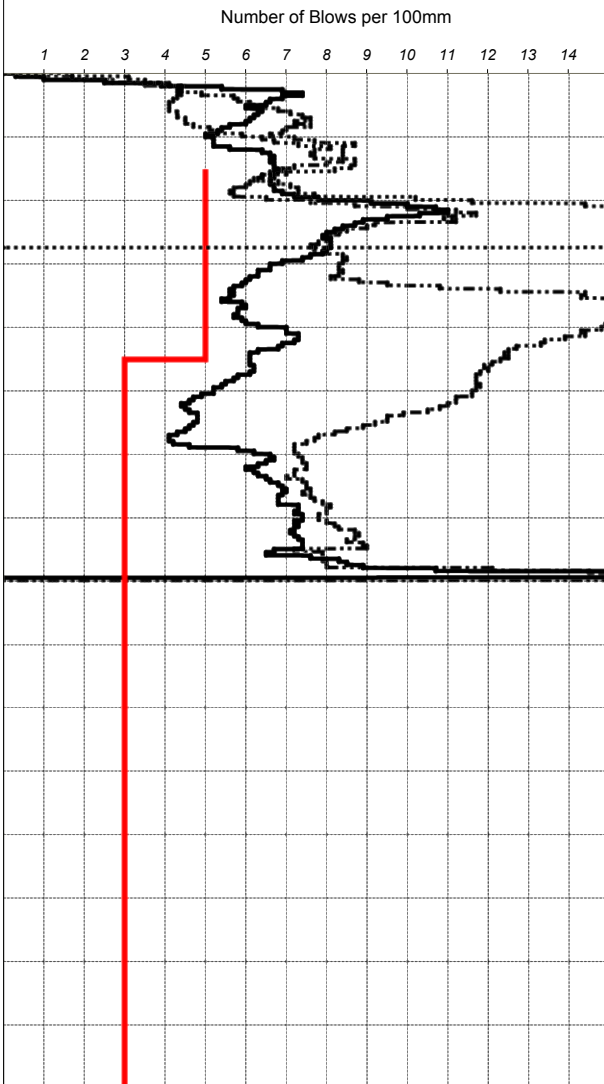
### SCALA PENETROMETER TEST RESULTS

Scala penetrometers undertaken by Canterbury Geotest Ltd using a Hydraulic penetrometer rig.

Typically, below the topsoil layer the penetrometer test results generally indicate a geotechnical ultimate bearing capacity >300 kPa. Standard foundations for dwellings within the scope of NZS 3604:2011 are suitable. Refer to MBIE Section 5.2 *Overview of new foundations options*.
