**Geotechnical and Foundation Report: Lot 26, Manakura Neighbourhood, Karamū Subdivision, Riccarton, Christchurch**

This report provides the geotechnical appraisal and foundation recommendations for Lot 26 (DP 518068), Manakura Neighbourhood, Karamū Subdivision, Riccarton, Christchurch.

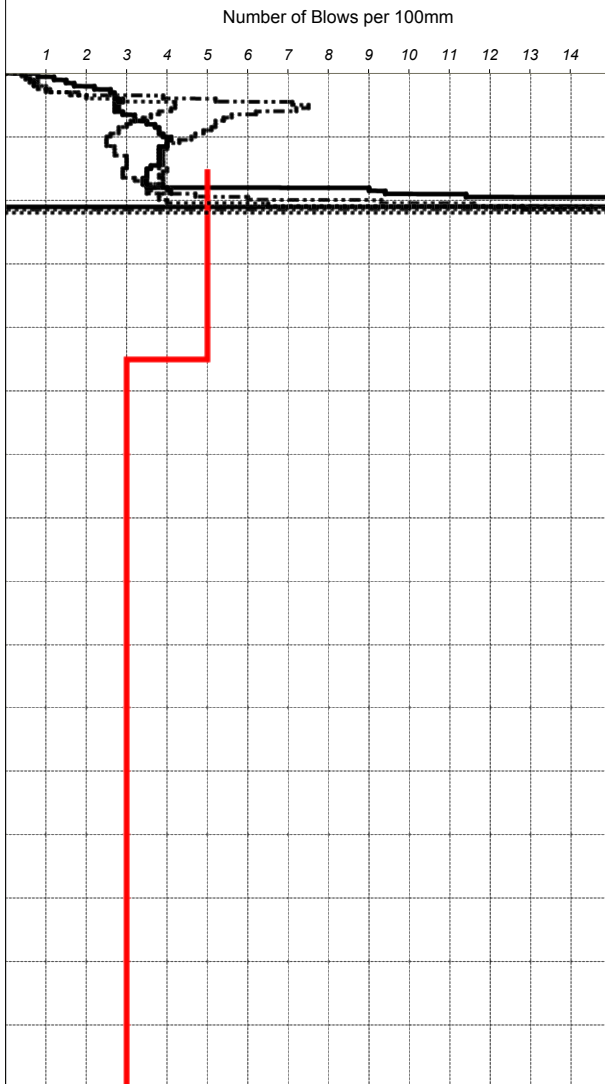
### SCALA PENETROMETER TEST RESULTS

— Lot 26 P01    - - - Lot 26 P02    ····· Lot 26 P03

Minimum penetration resistance (based on 300mm wide footing founded at 300mm depth) required for "Good Ground" as defined in the Acceptable Solutions and Verification Methods for NZBC Clause B1 Structure.

Scala penetrometers undertaken by Canterbury Geotest Ltd using a Hydraulic penetrometer rig.

Typically, below the topsoil layer the penetrometer test results generally indicate a geotechnical ultimate bearing capacity >300 kPa. Standard foundations for dwellings within the scope of NZS 3604:2011 are suitable. Refer to MBIE Section 5.2 *Overview of new foundations options*.
